Tree Service Inspection Preliminary Report

Park View estate mulberry tree

Location: Park View Estate, Islington

Date of inspection: 16 February

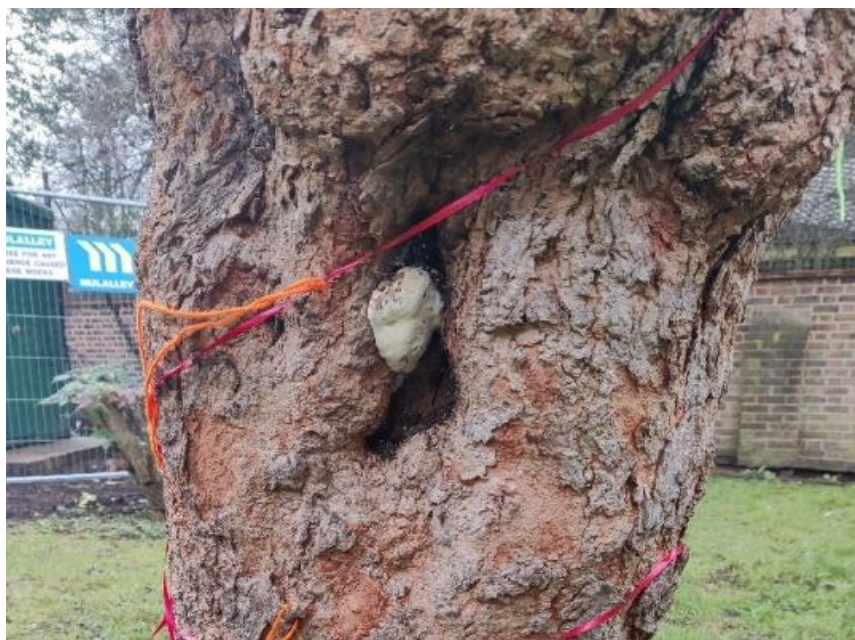
The tree was found to have Ganoderma fungal fruiting bodies on the stem. This fungus is known to cause a progressive heartwood decay for which there is no treatment.

The internal decay and subsequent impact on the trees vitality does mean that its lifespan is significantly reduced. Ultimately, the decay will cause the tree to become structurally unsound and fail (fall over).

Fig.2 The Ganoderma is the amorphous white blob in the centre of the photo

While the mulberry tree may survive for a number of years with this type of decay, its health and form will decline over its remaining life.

Due to its location, the risk associated with the tree falling is low, it's extremely unlikely to hit or damage anything. At this stage, notwithstanding the planning permission for removal, the tree would normally be retained and monitored. The tree service don't remove trees at the first signs of decay or defect, we monitor and remove when the risk of failure outweighs the amenity and benefits provided.

A dying and declining tree of this size is not normally considered to be a constraint to development. Rather than designing a building to accommodate a tree with a reduced life expectancy, it is better long term tree and landscape management to remove and replace it with more trees, which will grow to have increased amenity and environmental benefits.

The transplanting of the tree to a new location, was being considered, however the fungal decay and lowered vitality mean that the chances of successfully transplanting (moving) the tree are reduced considerably. The funds used for trying to transplant would be better used for re-planting.

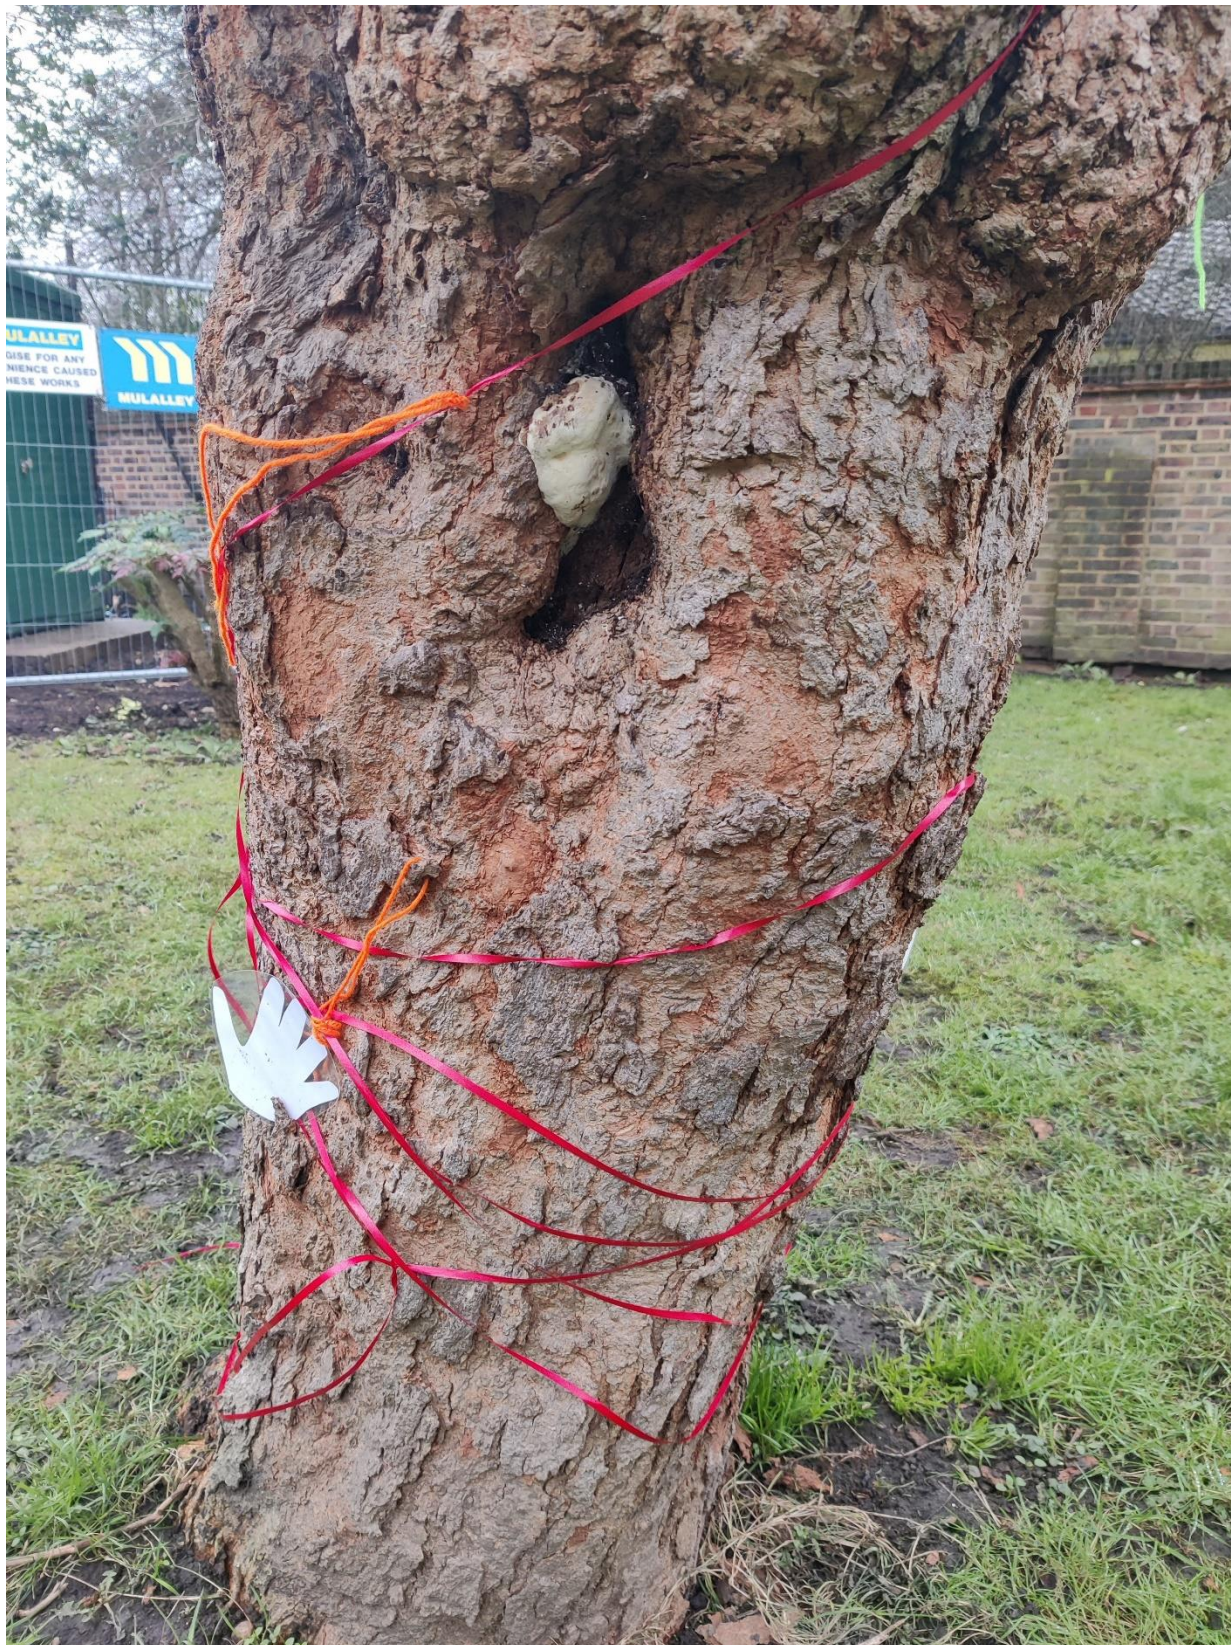
The Ganoderma is the amorphous white blob in the centre of the photo
