Arboricultural Report

for planning purposes

Barnard Park
Copenhagen Street
Islington
N1 0ER

210260-PD-11b

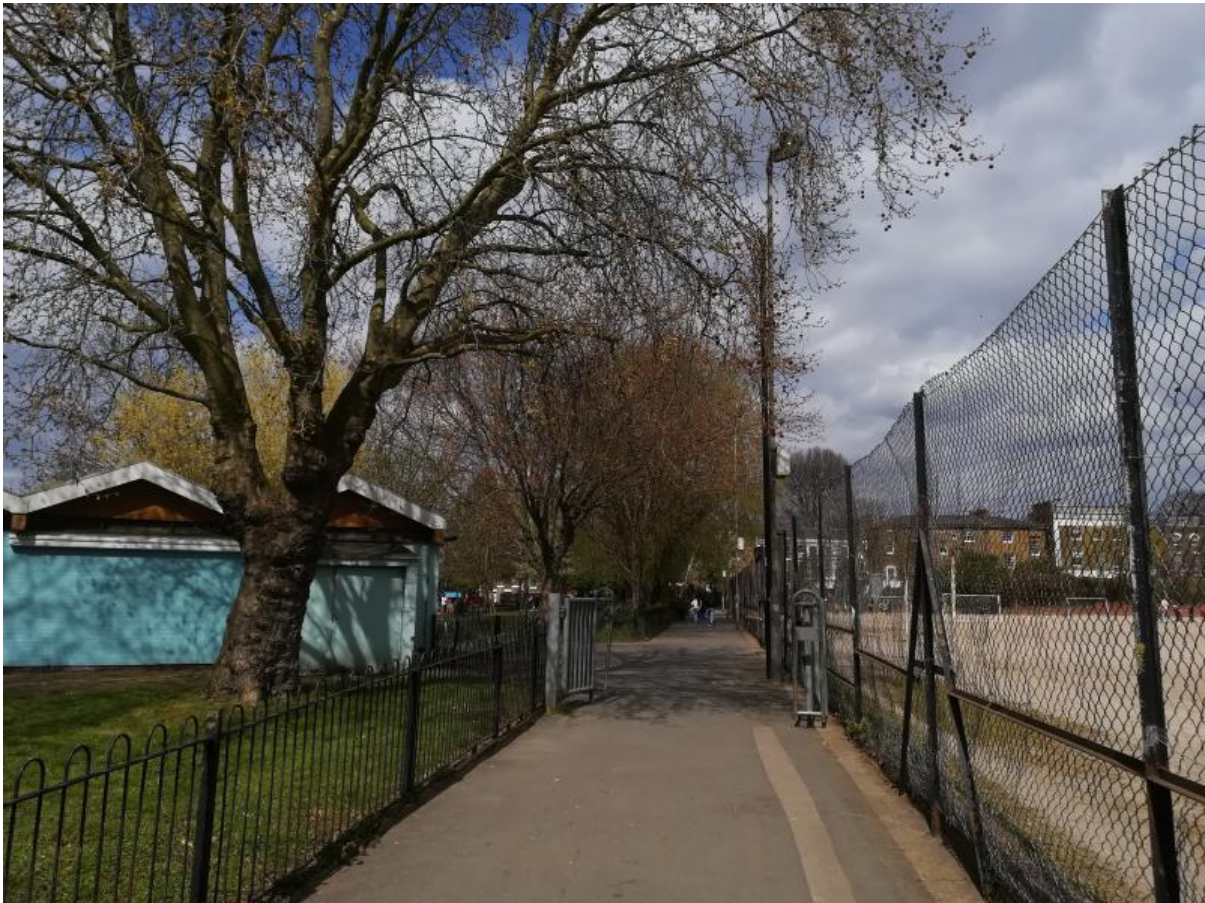
6.3 The most notable specified tree removal is that of the mature London plane tree (T1), which is a *Category A* specimen located within the centre of the Site to the west of the existing sports pitch. The reasons for its removal are as follows:

- It does not integrate sustainably with the layout of the Site in its proposed development form; and
- It will be subject to an ongoing and significant risk of harm, during works to implement the proposed development (if it were retained).

Photo 4: Looking north along the western edge of the existing sports pitch, showing the mature plane tree (T1) to the left.

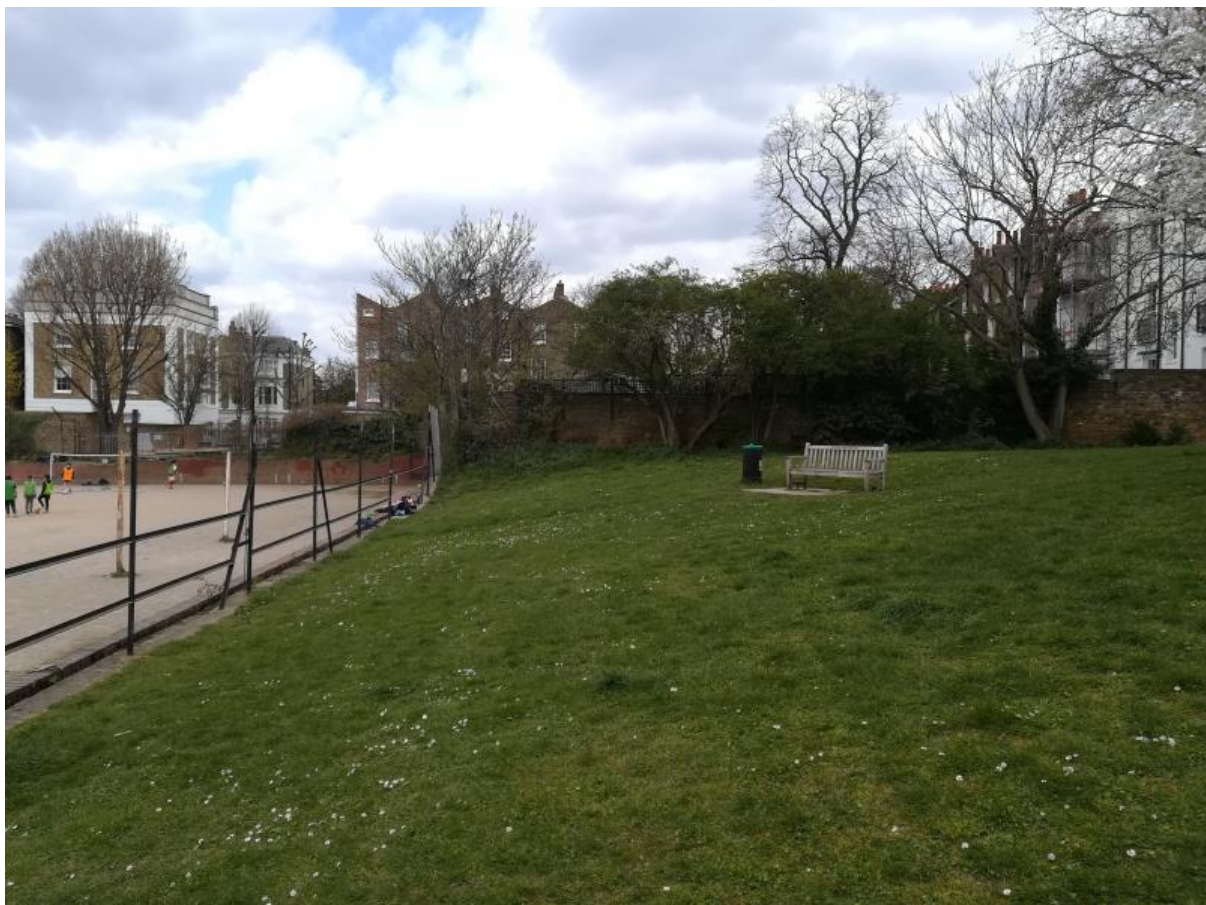
- 6.27 It is understood at this stage, however, that the retaining wall along the northern edge of the sports pitch (see Photo 7 below) will be retained and 'buried' within the new landscaped area involving the raising of levels. This significantly reduces the impact to the trees growing at the higher level the other side of this wall, effectively enabling their retention. Whilst this wall will mean that a root barrier remains present, its removal would very likely destabilise the ground within which the adjacent trees are rooting and in turn may result in a degree of destabilisation to the trees (which would likely require their removal).
- 6.28 It may be possible to remove select bricks from the wall, as a compromise, to allow roots to grow through the wall and into the new landscaped area, provided the stability of the wall is not undermined before landscaping works occur.

Photo 7: Looking north towards the northern boundary of the Site, showing the retaining wall along the northern edge of the sports pitch and T161 (rear left).

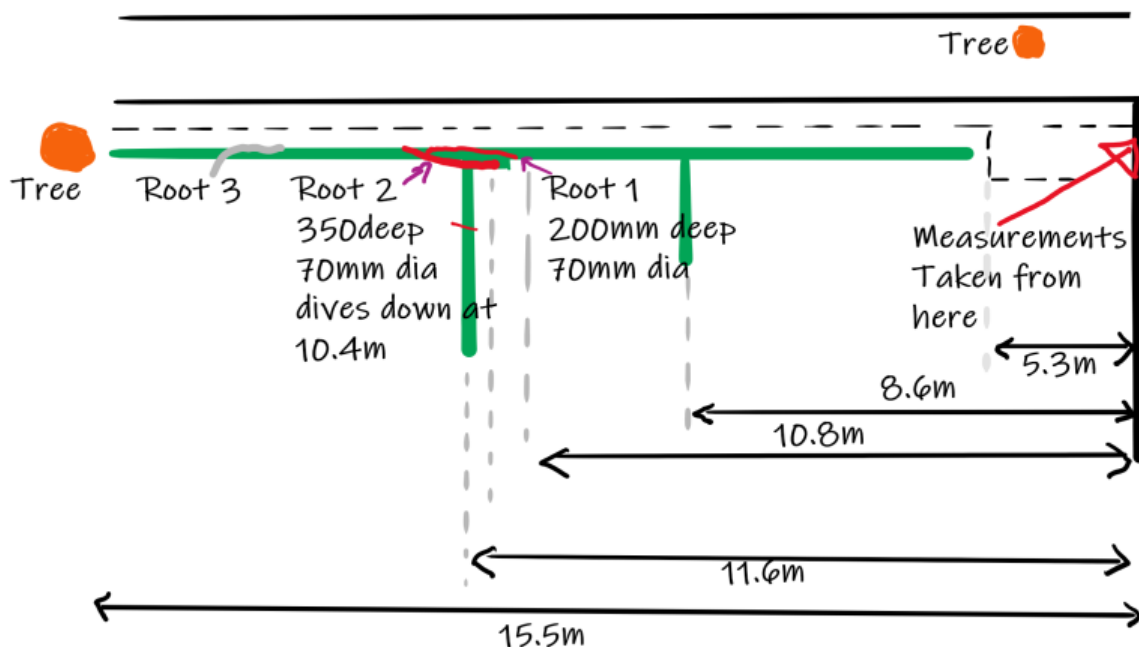
Figure 1: Showing a sketch of the findings of the compressed air excavations north of T34 (left tree; right tree is T140).

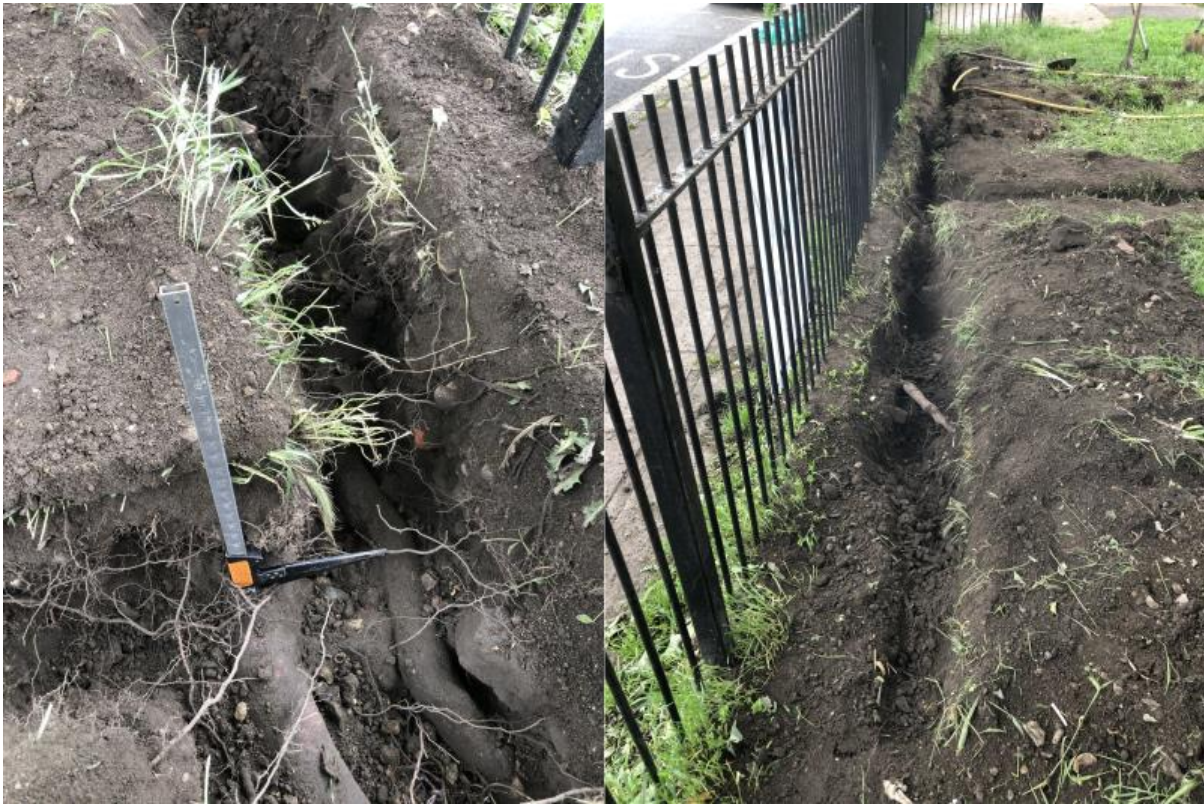
Photo 10 (left) and Photo 11 (right): Showing roots uncovered from 200mm below ground level from T34, within a trench running parallel with the public footpath to the west.
