Arboricultural Report

for planning purposes

Barnard Park
Copenhagen Street
Islington
N1 0ER

210260-PD-11b

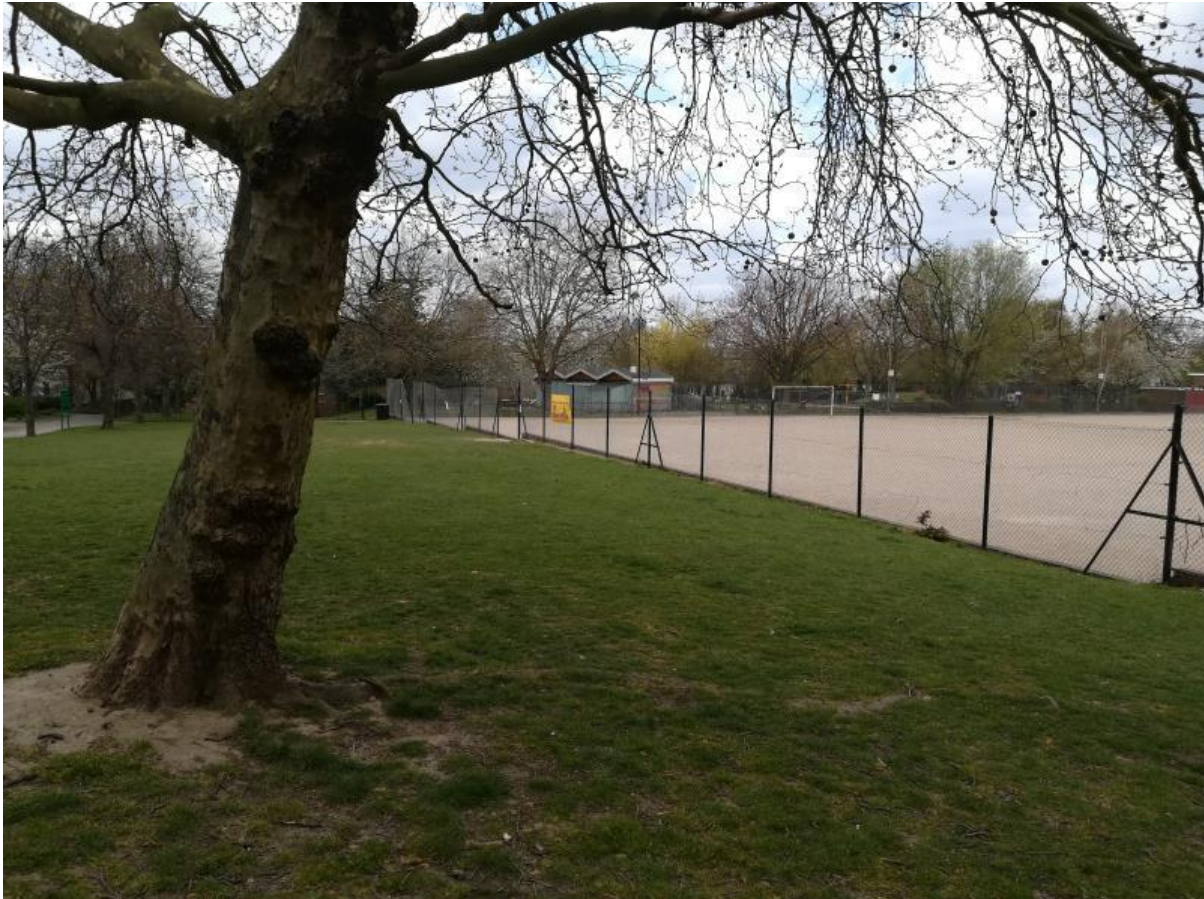
Photo 1: Looking north-west towards the multi-purpose pitch from the base of T95, showing T96 (front left) and the trees behind (including T1 and T113-T121).

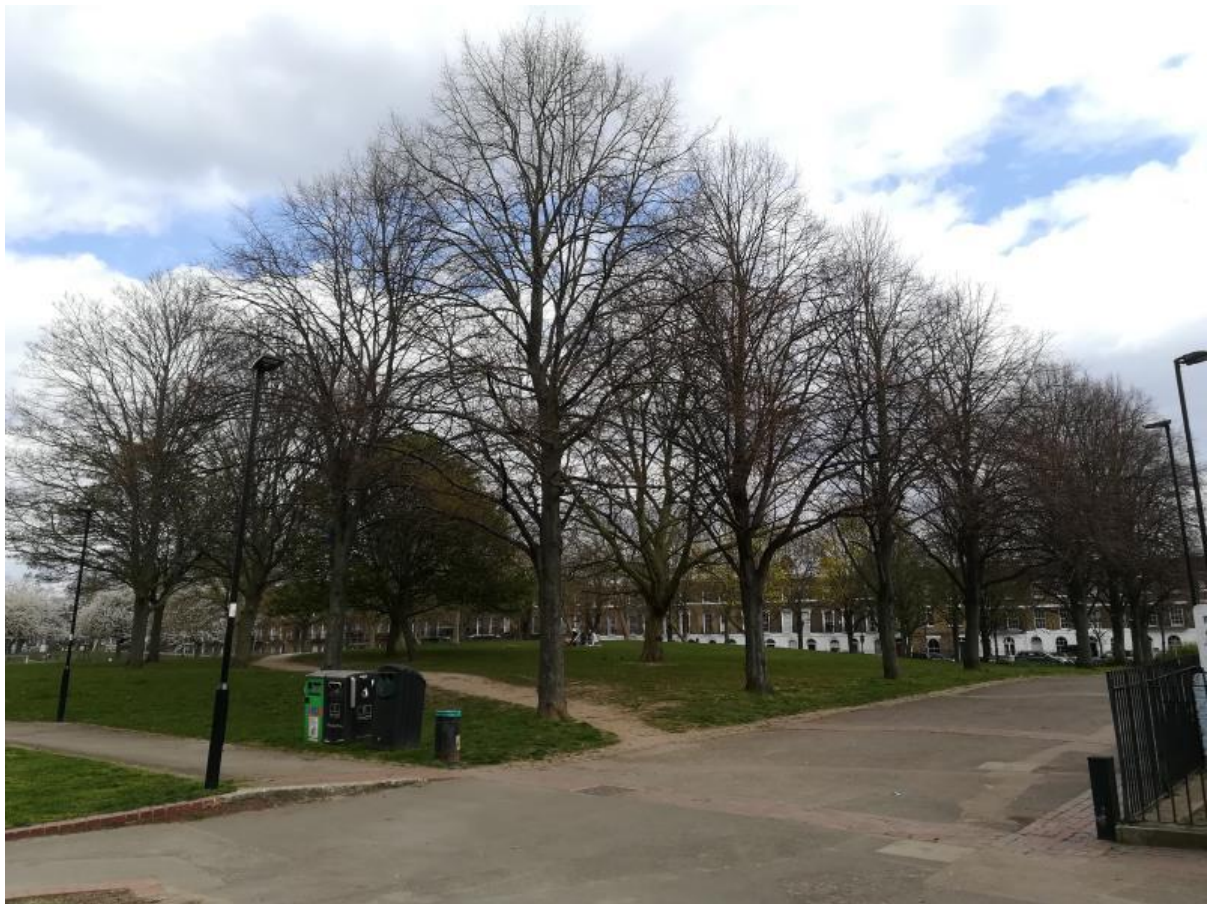
Photo 2: Looking north-east into the eastern section of the Site, showing the linear lime tree belt defining the edge of the grass area (T45 to the front centre, as a location of reference).

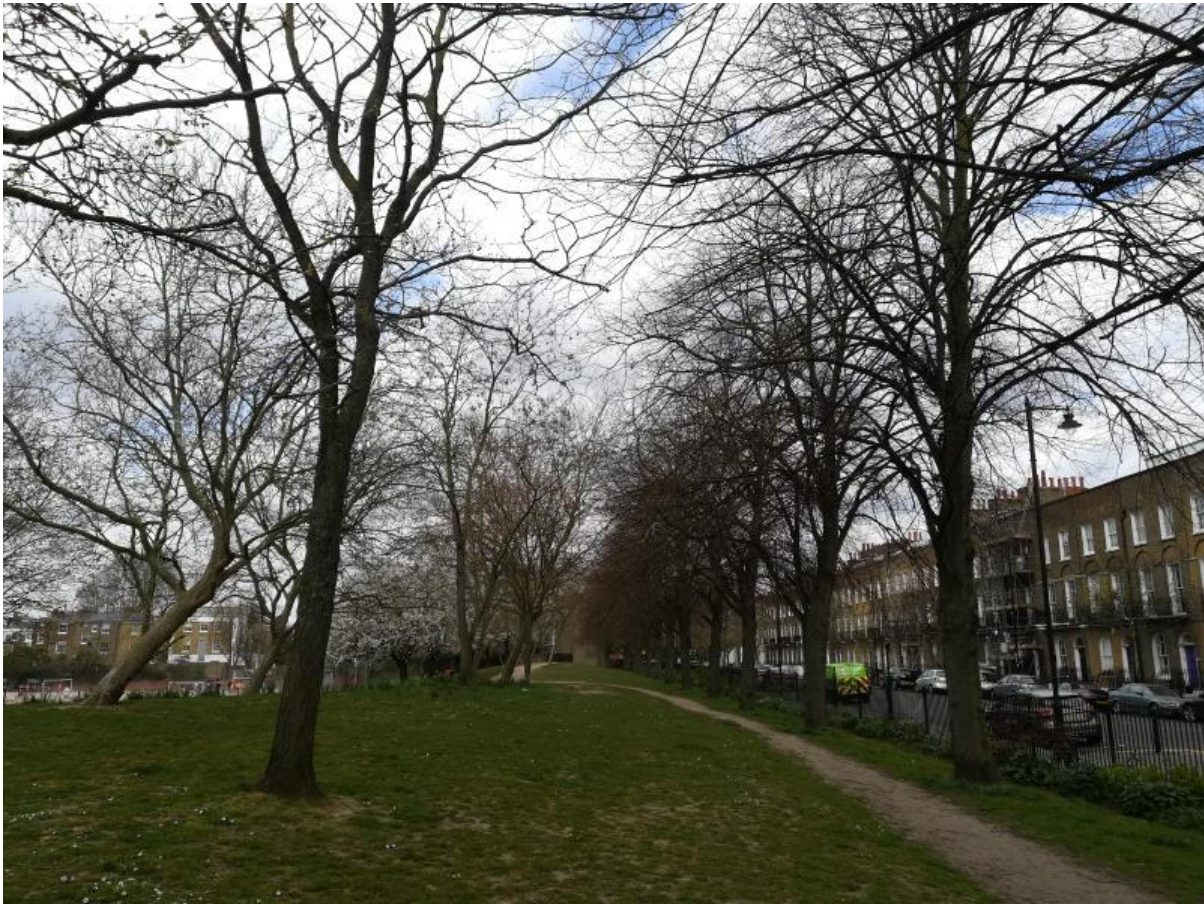
- 4.7 Whilst the individual quality of many trees is good, it is in their collective presence that their value is most pronounced (e.g., the line of *Category A* lime trees along the eastern boundary of the Site - see Photo 3 below), because the trees create a verdant oasis within a dense urban area. During summer, the Site is covered extensively by tree canopy, around the existing sports pitch, forming a visual buffer from the built environment and providing welcome shade. In this sense, the trees located more central to the Site are of slightly less comparative value, unless viewed from within the Site itself.

Photo 3: Looking north along the eastern edge of the Site, showing T101 (front left) and T58-T69 (right), amongst other trees within the area.

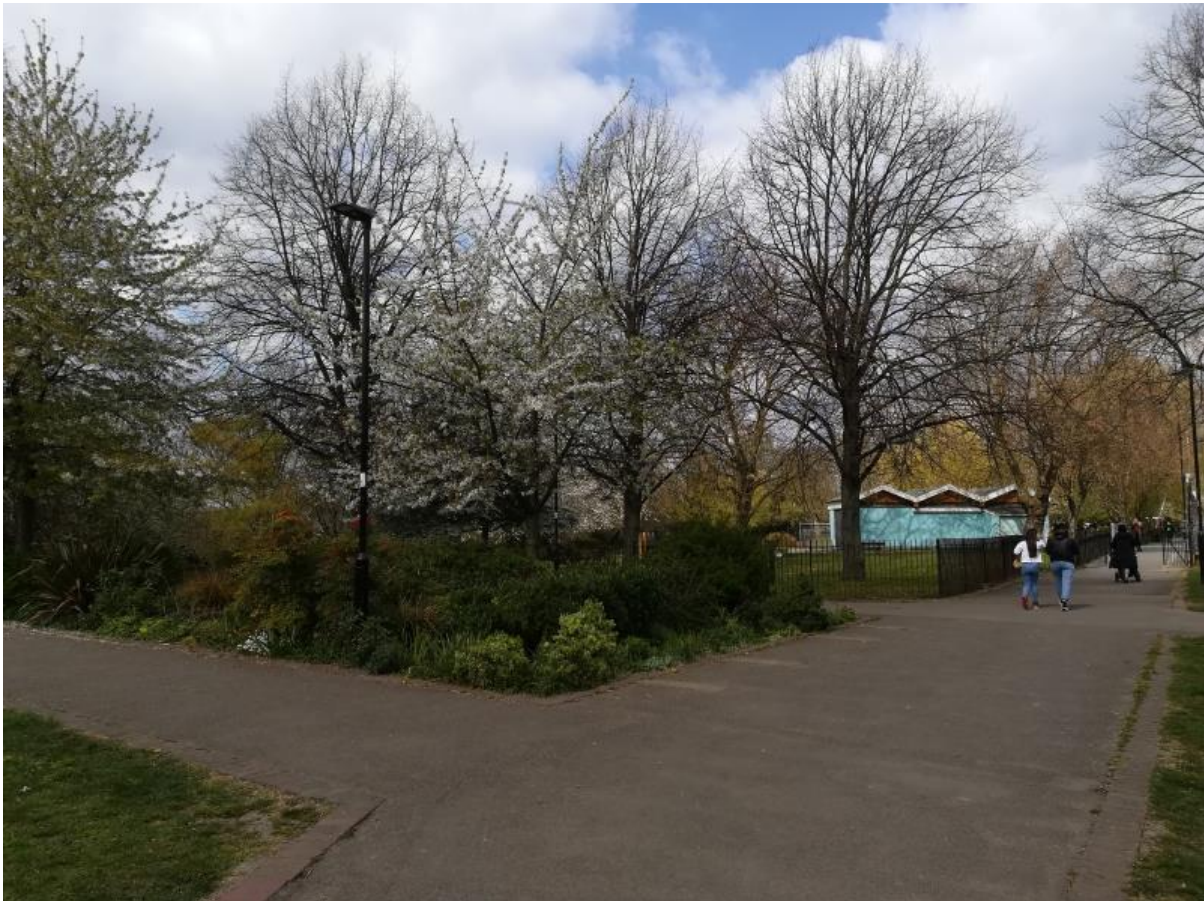
- T18 and T20 (to the south-west of the existing sports pitch - see Photo 5 below);
 - T87 (to the east of the existing sports pitch); and
 - T147-T153 (to the west of the existing sports pitch and to the north of the closed community building).

Photo 5: Looking north-west towards the existing crossroads area, showing various trees including T20 (centre) and T18-T19 and T22-T23 (behind T20).

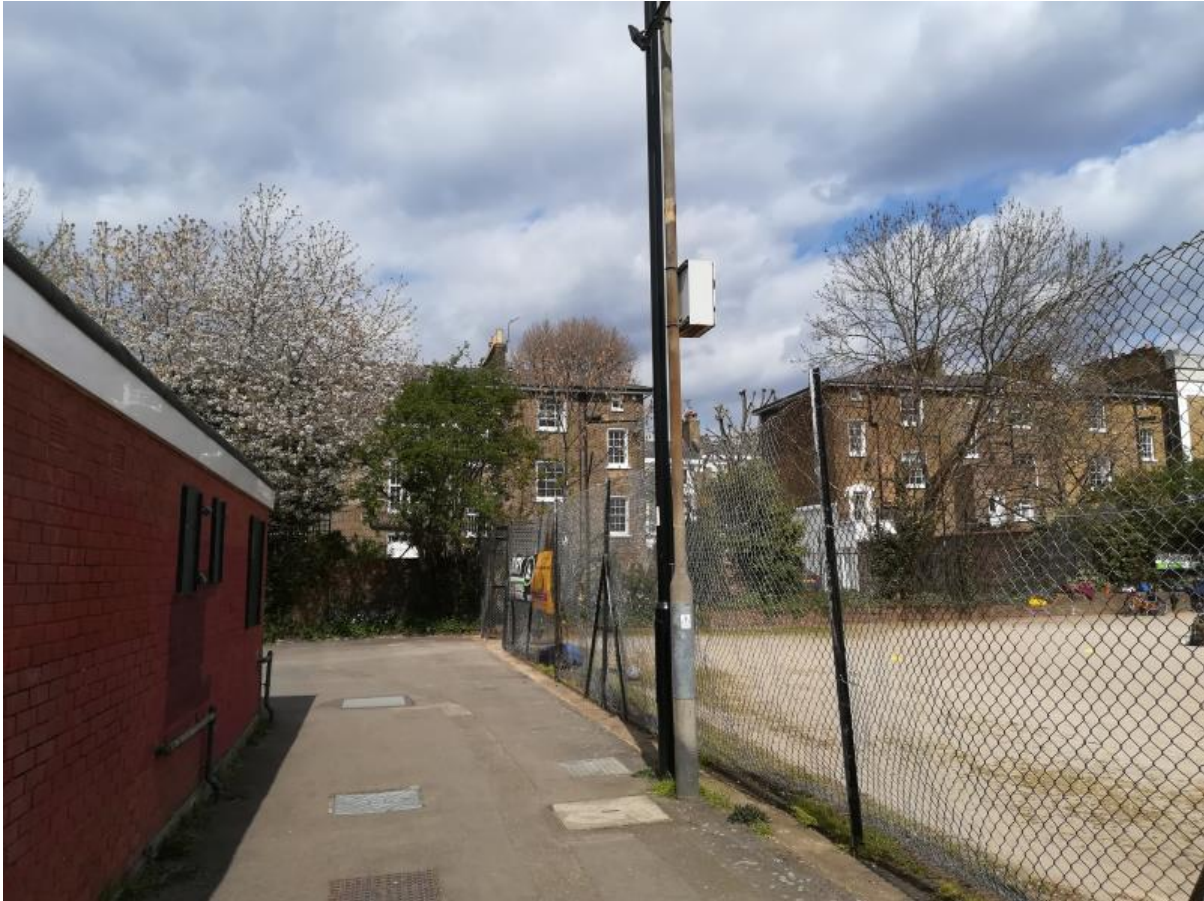
Photo 6: Looking north-east into the existing sports pitch, showing T125-T126 (far right) along its northern edge.

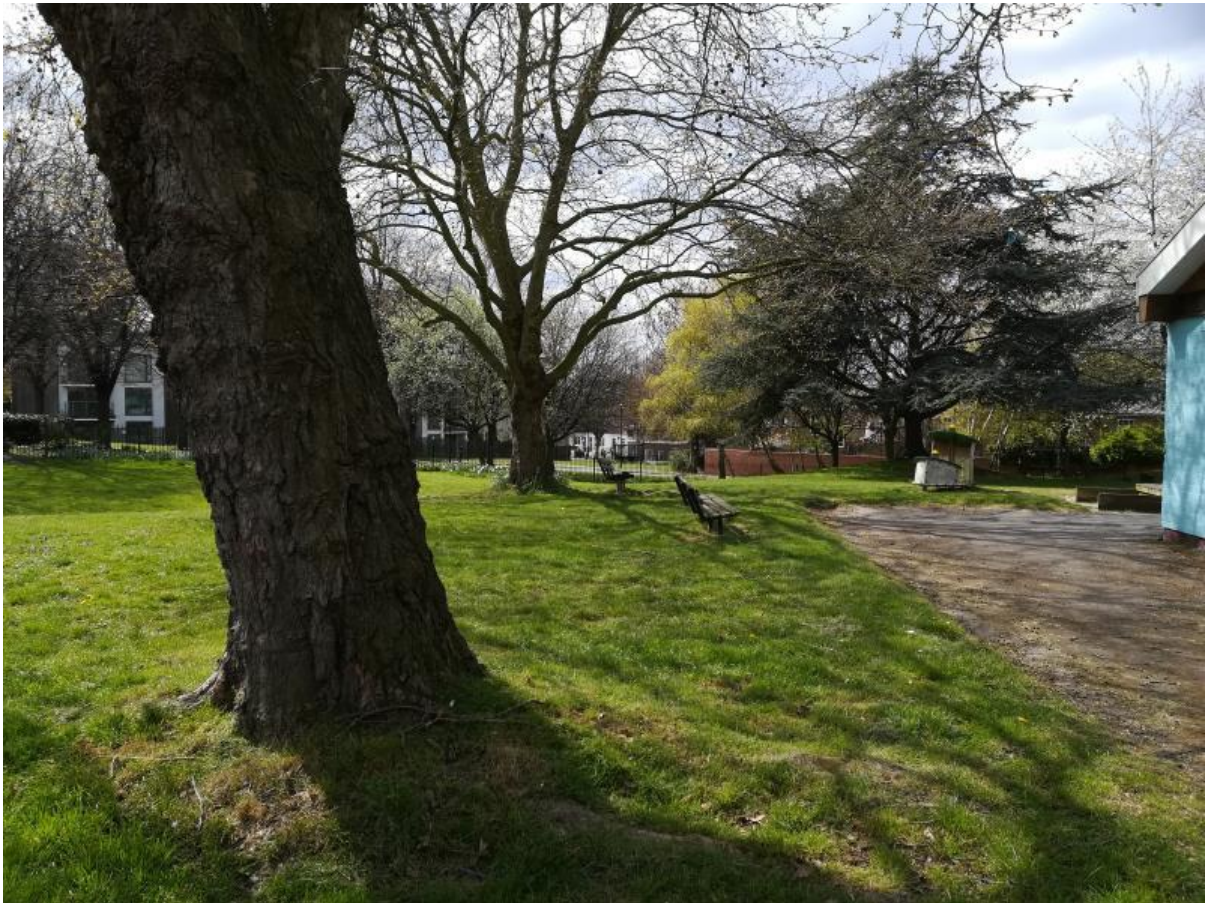
- 6.31 The approach to the demolition of the existing community building is not currently confirmed, though it is located predominantly outside of nominal RPAs and therefore it is considered that it can be removed in a manner that presents a low risk of harm to adjacent trees including T2 (see Photo 8 below) - and subject to compliance with the specifications of tree protection, as set out in principle within the TPP and to be developed within an AMS.

Photo 8: Looking south-west along the southern edge of the existing community building, showing T2 (rear centre-left) and other surrounding trees.

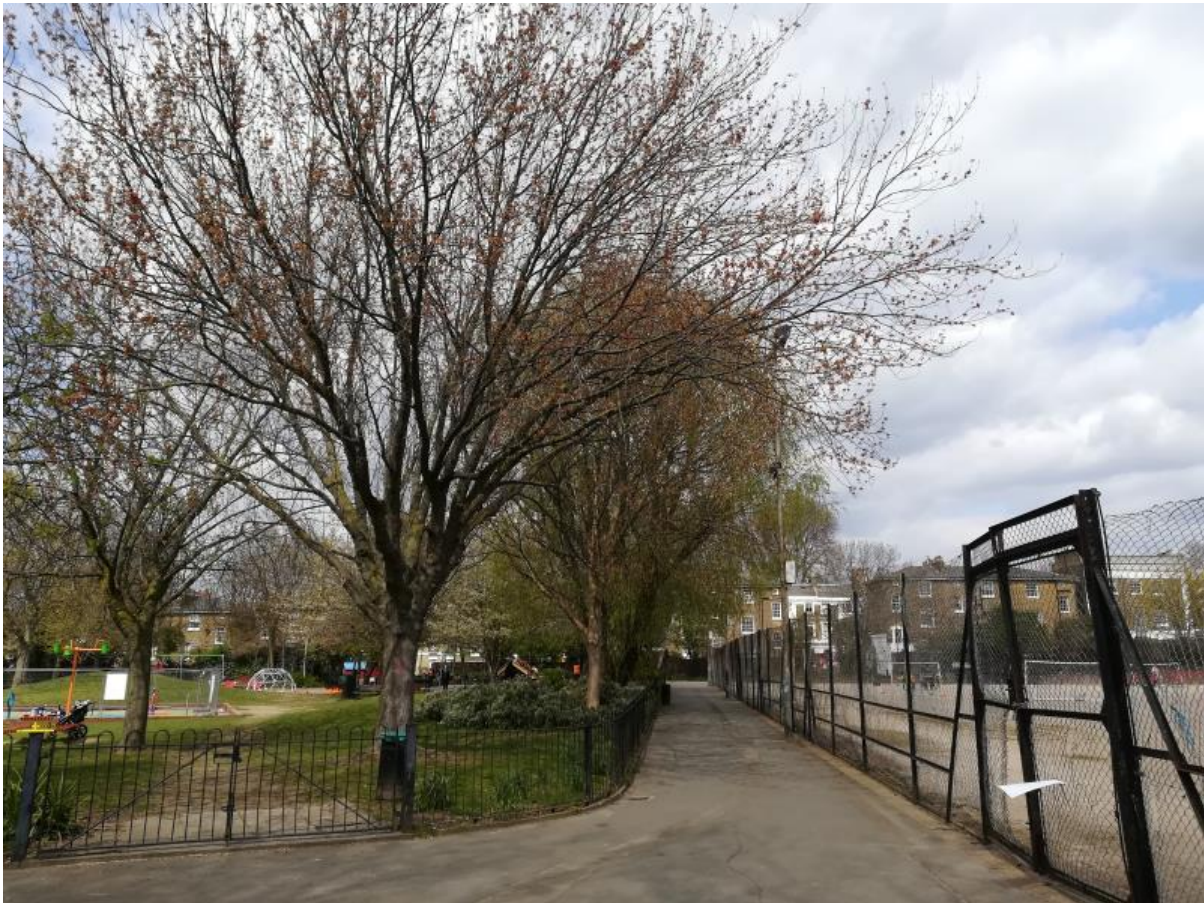
- 6.32 The approach to the construction of the new community building is not currently confirmed, though it is located outside of nominal RPAs and therefore it is considered that it can be removed in a manner that presents a low risk of harm to adjacent trees including T2 (see Photo 8 above) and T113 (see photo 9 below) - and subject to compliance with the specifications of tree protection, as set out in principle within the TPP and as to be developed within an AMS.

Photo 9: Looking north along the western edge of the existing sports pitch, showing T113 (centre left).
