Cyclical Improvement Works

Resident consultation

EP04 - Highbury New Park

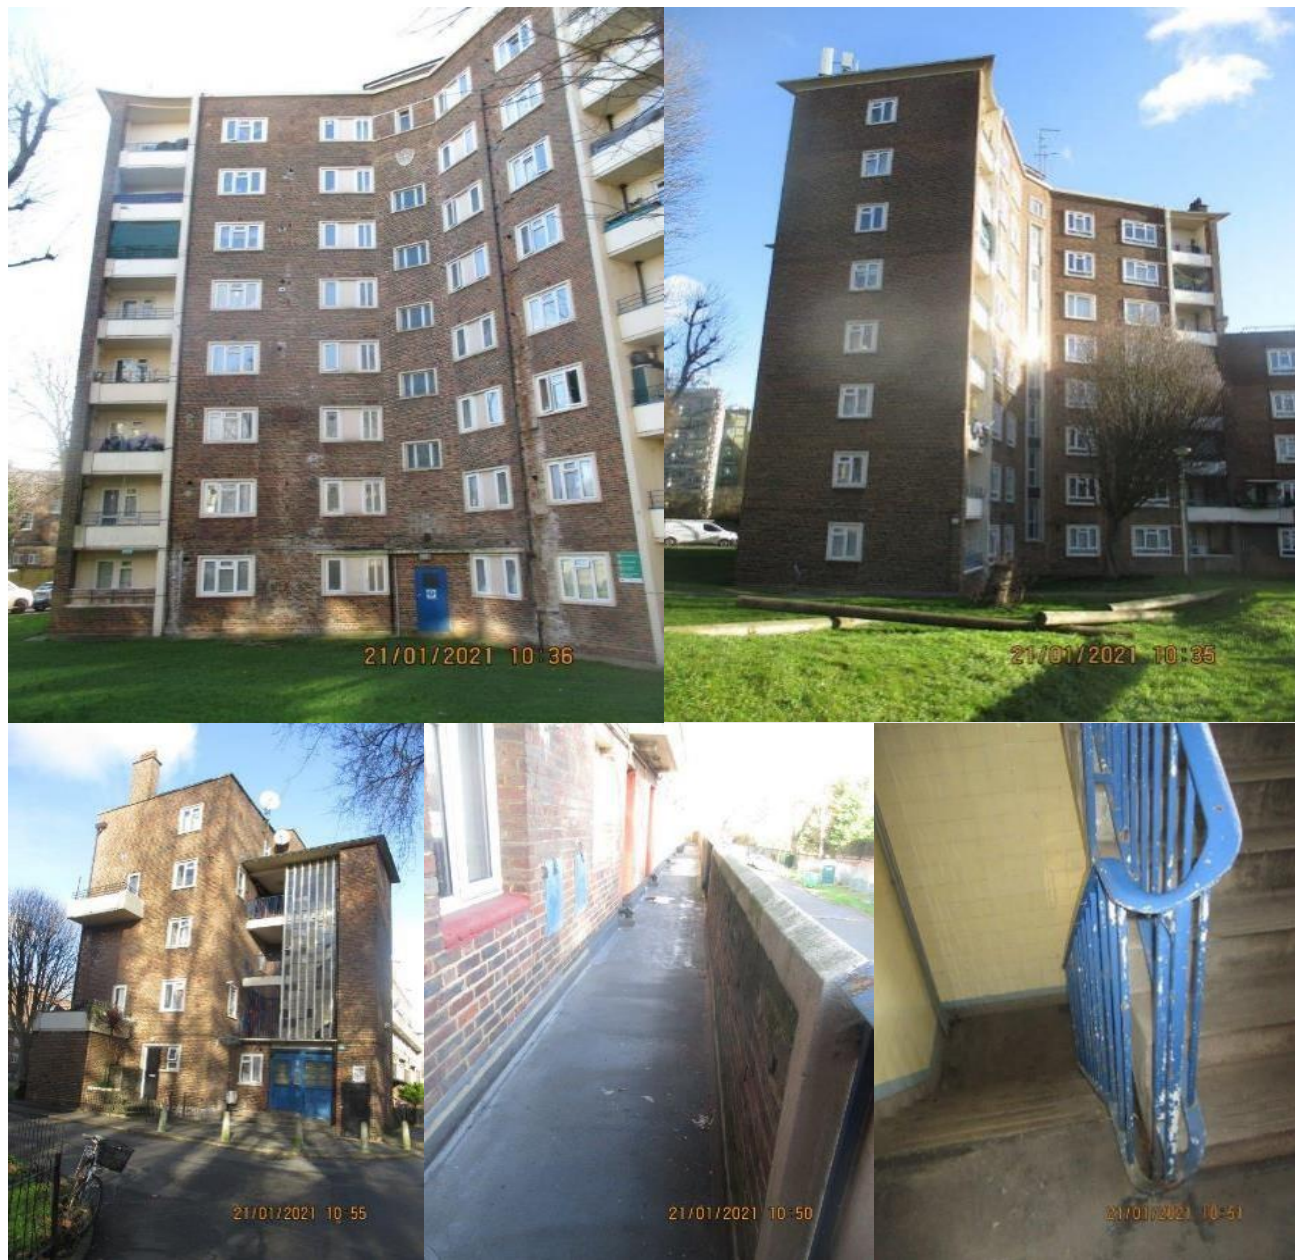
1. 1-52 Park View

1-52 Park View is a unique block on the estate, that was constructed in 1954. It is an 8-storey block constructed in reinforced concrete frame with brick infill and a connected adjoining 4-storey low-rise section in brick construction with cantilevered balconies. The low-rise section has a taller 5-storey section at the southwest facing gable end. The block also benefits from a controlled door entry system. The works to be undertaken at this block will require us to erect a scaffolding (Tube & Clip) to the entirety of the building. This will enable to gain access to difficult

The need for works to all roofs are essential to eliminate the possibility of leaks and ensure these areas are retaining heat during the cold months of the year by making sure high levels are free from defects. Works to these surrounding areas will include

- The clearance of outlets, cleaning of moss
- Minor flat roof repairs to felt overlay, repointing of flashing around chimney stacks
- Checking and test of the lightning conductor.

- Ease and adjusting of all windows and renewal of missing ironmongery
- Renewal of putty and some Georgian wire glass to the communal areas.

- Brickwork, concrete and render repairs will be undertaken to large areas of 1-25 which will include brick tint and staining
- Repairs to tiled porch outside maisonettes front entrance doors
- Renewal of expansion joints
- Water resistant treatment to ground floor brickwork
- Jet washing of brickwork
- In block 1-25 clean out bin hoppers to each floor (including easing and adjusting), remove pigeon guano from secondary means of escape leading to the rear of the block.
- We plan on relocating the bin storage area to the grass area opposite 1-25 Park View due to the current location of the bins posing a possible fire risk.

The low-rise block where flats 25-52 are located, will undergo works aimed at strengthening the communal walkway balustrades. The initial plan was to demolish the wall and replace this with a powder coating railing that would match the design of the New Build homes. However, we would rather adapt the current design and overall look of the block.

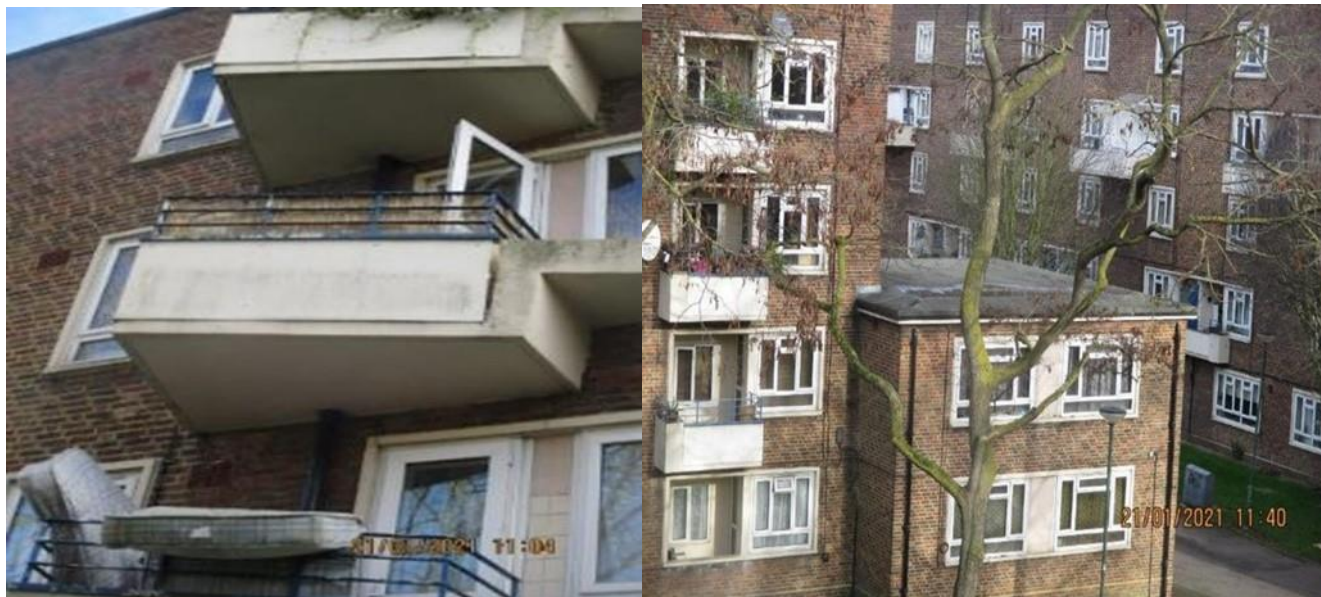
2. 53-68 Park View

Blocks 53-68 Park View are of a similar style to Block 1-52, built in brick and reinforced concrete frame construction with a cantilevered protruding stairwell and flat roofs. This block consists of four and two storey blocks. Due to the extensive works that will be undertaken at 53-68 Park View all elevations will need to have a (Tube and Clip) scaffolding erected. These works consist of the following:

Scaffolding of the whole block (4-storey and a 2-storey section at the end) will be essential for most of the repairs undertaken at the blocks for Park View.

The need for works to all roofs and works at high level are essential to eliminate the possibility of leaks and ensure these areas are retaining heat when it is cold by making sure high levels are free from defects. Works to these surrounding areas will include:

- The clearance of outlets, cleaning of moss
- Minor flat roof repairs to felt overlay, repointing of flashing around chimney stacks
- Checking and test of the lightning conductor
- Testing such as moisture mapping and core samples maybe taken to determine
- Repointing flashing around chimney stacks
- One layer felt overlay to pram sheds

- Ease and adjusting of all windows and renewal of missing ironmongery
- Renewal of putty and some Georgian wire glass to the communal areas.

- Brickwork, concrete and render repairs, to include brick tint and staining
- Renewal expansion joints

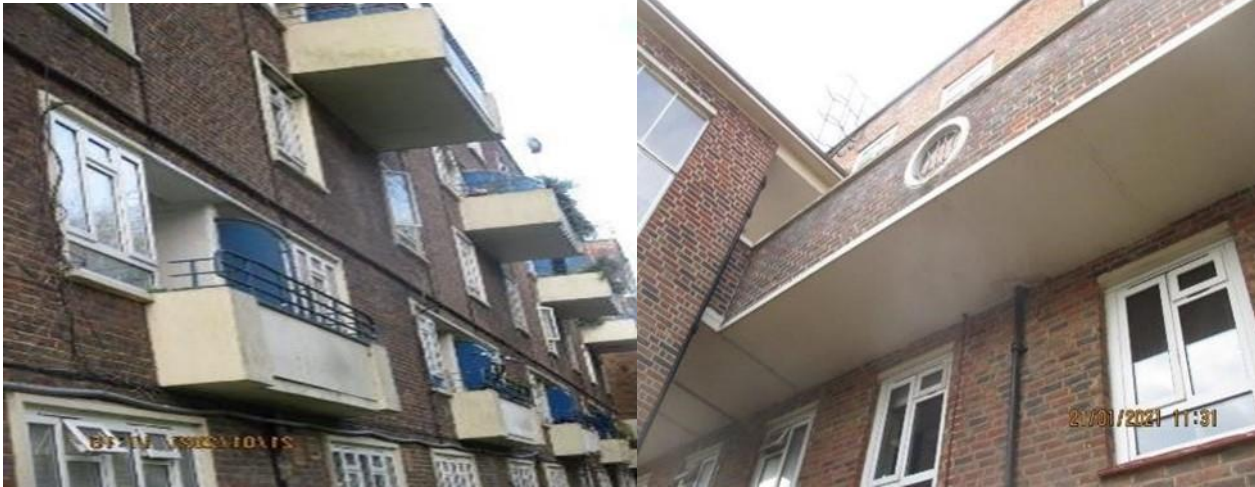
3. 69-96 Park View

Blocks 69-96 Park View is of the same style as the low-rise section of block 1-52. Built in brick construction and reinforced concrete frame with cantilevered communal balcony walkway to the front elevation and individual balconies to the rear elevation and a flat roof system. The works required for this block will require a Tube and Clip scaffolding that will be erected to both two and four storey blocks in order for the following works to be undertaken:

- The clearance of outlets, cleaning of moss
- Minor flat roof repairs to felt overlay
- Repointing of flashing around chimney stacks
- Clear and wash down rainwater goods
- Checking and test of the lightning conductor
- Testing such as moisture mapping and core samples may be taken to determine. We will repoint flashing around chimney stacks.
- One layer felt overlay to pram sheds

- Ease and adjusting of all windows and renewal of missing ironmongery
- Renewal of putty and some Georgian wire glass to the communal areas

- Repairs to tiled porch outside maisonettes front entrance doors
- Renewal of expansion joints.

Low-rise blocks containing walkways will undergo works aimed at strengthening the balustrades to the communal walkways. The initial plan was to demolish the wall and replace this with a powder coating railing that would match the design of the New Build. However, we would rather adapt the current design and overall look of the block.

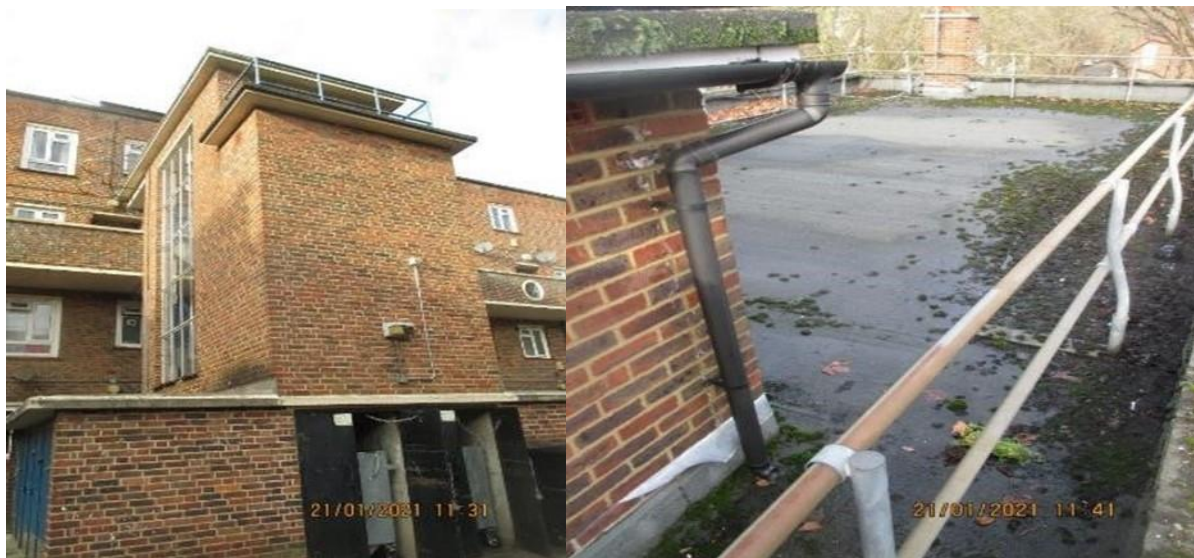
4. 109-118 Park View

Blocks 109-118 Park View are of a similar style to Block 1-52, built in brick and reinforced concrete frame construction with a cantilevered protruding stairwell and flat roofs. This block consists of four and two storey blocks. Due to the extensive works that will be undertaken at 109-118 Park View all elevations will need to have a (Tube and Clip) scaffolding erected. These works consist of the following:

- The clearance of outlets, cleaning of moss
- Minor flat roof repairs to felt overlay, repointing of flashing around chimney stacks
- Checking and test of the lightning conductor
- Testing such as moisture mapping and core samples maybe taken to determine. We will repoint flashing around chimney stacks
- One layer felt overlay to pram sheds

- Ease and adjusting of all windows and renewal of missing ironmongery
- Renewal of putty and some Georgian wire glass to the communal areas.

- Brickwork, concrete and render repairs, to include brick tint and staining
- Renewal expansion joints

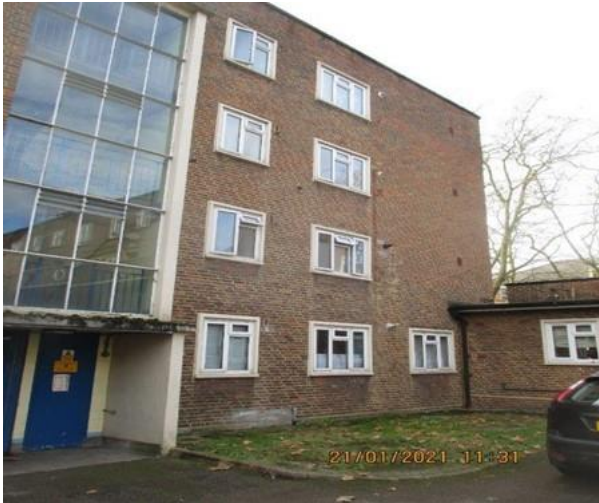
5. 119-142 Park View

119-142 Park View Estate are of the same style as the low-rise section of block 1-52. Built in brick construction and reinforced concrete frame with cantilevered communal balcony walkway to the front elevation and individual balconies to the rear elevation and a flat roof system. This block consists of four and two storey blocks. Due to the extensive works that will be undertaken at 109-118 Park View all elevations will need to have (Tube and Clip) scaffolding to be erected. These works consist of the following:

- The clearance of outlets, cleaning of moss
- Minor flat roof repairs to felt overlay, repointing of flashing around chimney stacks
- Checking and test of the lightning conductor
- Testing such as moisture mapping and core samples may be taken to determine
- Repointing flashing around chimney stacks.
- One layer felt overlay to pram sheds

- Repairs to tiled porch outside maisonettes front entrance doors
- Renewal of expansion joints.

Low-rise blocks containing walkways will undergo works aimed at strengthening the balustrades to the communal walkways. The initial plan was to demolish the wall and replace this with a powder coating railing that would match the design of the New Build. However, we would rather adapt the current design and overall look of the block.

- Installation of tensile rods within walkway balustrades to provide required reinforcement.
- Complete resurfacing of the communal balcony walkway surfaces using a product that incorporates a new insulation layer. Creating channels in the existing water gullies to ensure rain falls into the gullies and is drained away.
- Replacement of gully grids to walkways and connected down pipes – cast iron – repair sections and seal around entrances into flats where and when necessary.

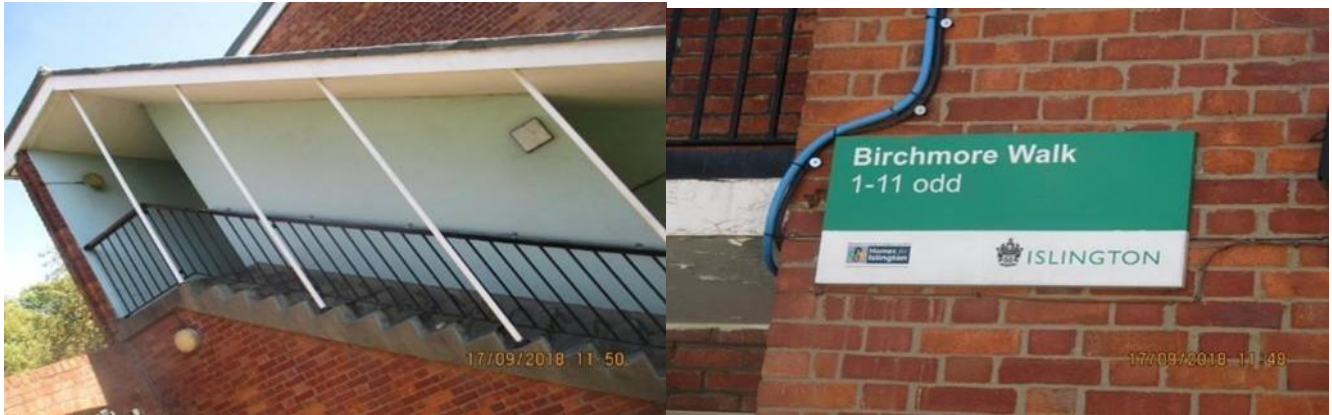
6. 1-11 Birchmore Walk

1 to 11 Birchmore Walk is part of a open aspect 2-storey blocks are of a similar style, both are cavity wall brick construction with reinforced concrete deck and frame with low-level pitched roofs. The main differences are the yellow brick façade construction. These works consist of the following:

- Scaffolding of the whole block will be essential to gain access to areas where works are required to be undertaken at the blocks for Birchmore Walk
- Minor roof repairs to main pitched roof including replacement of broken tiles, damaged battens and isolation to be checked and replaced if required.

- Easing and adjusting UPVc windows including replacing missing ironmongery.

- Brickwork and concrete repairs including brick tint and stain removal.

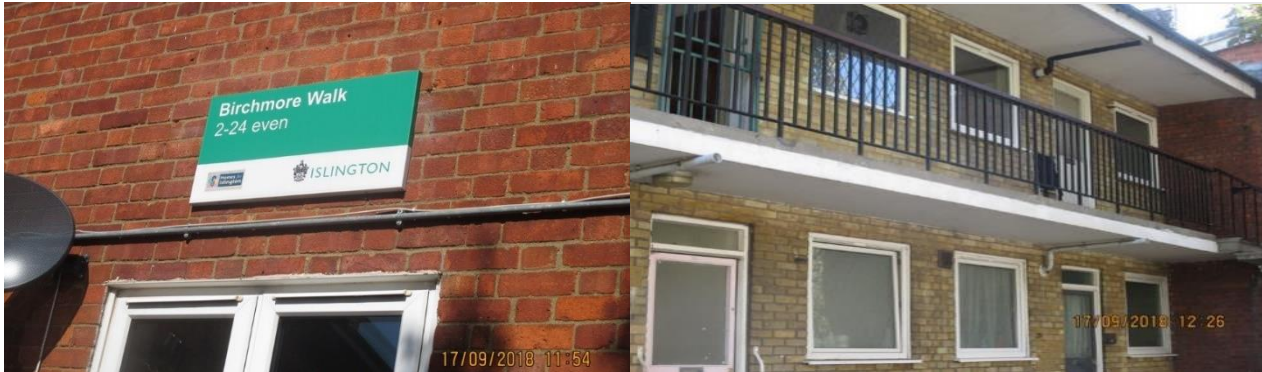
7. 2-24, 26 - 48 and 50 – 72 Birchmore Walk

2-24, 26 – 38 and 50-72 Birchmore Walk are three-storey style blocks that have built in cavity wall construction, solid walls at the gable ends with pitched roofs covered in artificial slate. These blocks also benefit from a controlled door entry system at the entrance to each protruding stairwell section. These works consist of the following:

- Scaffolding to whole rear of block (double check flank ends) and to stairwell entrances at the front of the blocks
- Repairs to pitched tiled roof to including refixing loose tiles, replace missing/broken tiles, clearing and realigning guttering and downpipes where required.
- Repairs to timber fascias and soffits. Application of weatherproof solutions.
- Checks to loft areas – replace insulation where required.
- Renewal of roof hatches top of landings.

- Tower (three-storey) for downpipe repairs etc to front elevation
- Repairs to front entrance porch roof – felt.
- Tidy cables where scaffold is erected only.
- Some masonry and brickwork repairs including any repointing and concrete repairs as well as brick tint and cleaning off stains.

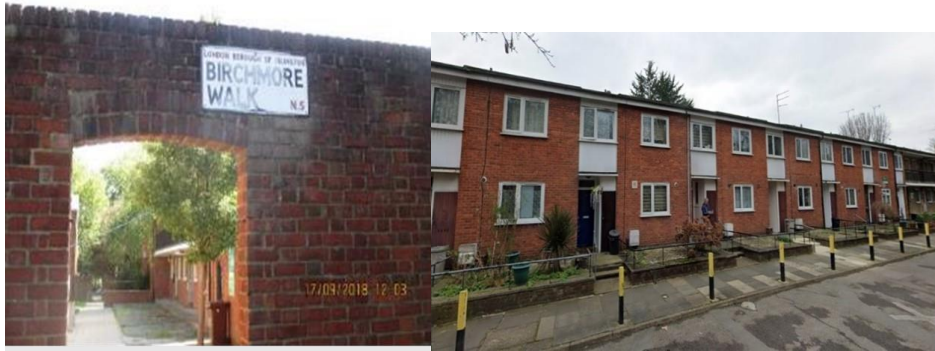
8. 13 – 25, 27 – 39, 41-61 and 73-85 Birchmore Walk

Blocks 13-25, 27-39, 41-61 and 73 - 85 Birchmore Walk are mainly two-storey terraced houses and individual homes. These have built in cavity wall construction with low-level felt covered pitched roofs with a recessed louvre window detail at regular intervals. The works required are as follows:

- Repairs to pitched tiled roof including refixing loose tiles, replace missing/broken tiles.
- Renewal of battens where required.
- Loft insulation to tenanted properties
- Clearing of rainwater goods including renewal of joints/brackets and small sections.
- Repairs to fascia/soffits and weatherproof solution applied.

- Brickwork repointing - including brick tint and stain removal

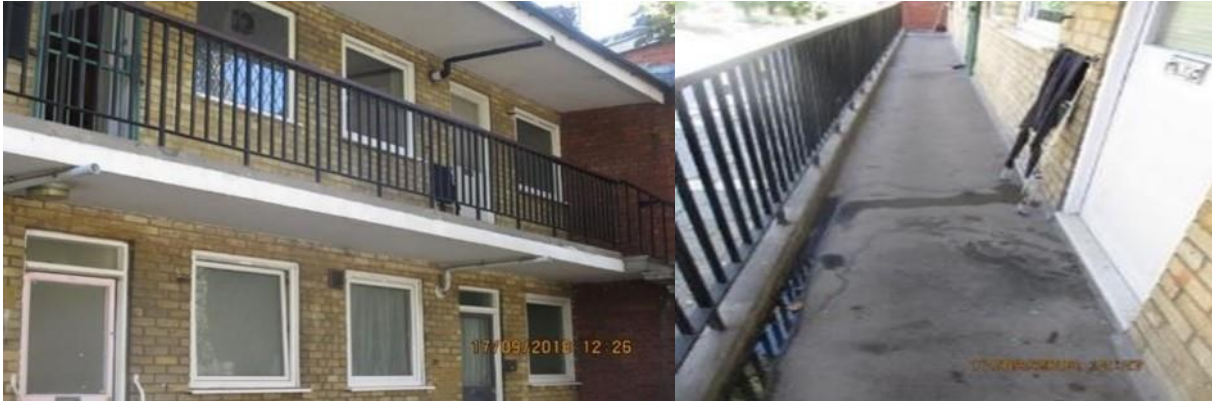
9. 63-71 Birchmore Walk

Block 63 -71 Birchmore Walk are open aspect two-storey blocks of a similar style, both are cavity wall brick construction with reinforced concrete deck and frame and low-level pitched roofs. The main differences are the yellow brick façade construction and rear elevation cladding detail on block 63-71. The works we have identified as being required at 63-71 Birchmore Walk are:

Minor roof repairs to main pitched roof including replacement of broken tiles, damaged battens and insulation to be checked and replaced if required including any flashings.

- Brickwork and concrete repairs Including brick tint and stain removal

- Fire compliancy works to cladding detail at rear elevation block 63-71 only. (To be confirmed after FRA survey recommendations for works to be undertaken after we start work).

- Recoating of the asphalt walkway to block which has deteriorated in new PMMA water resistant cold applied coating.

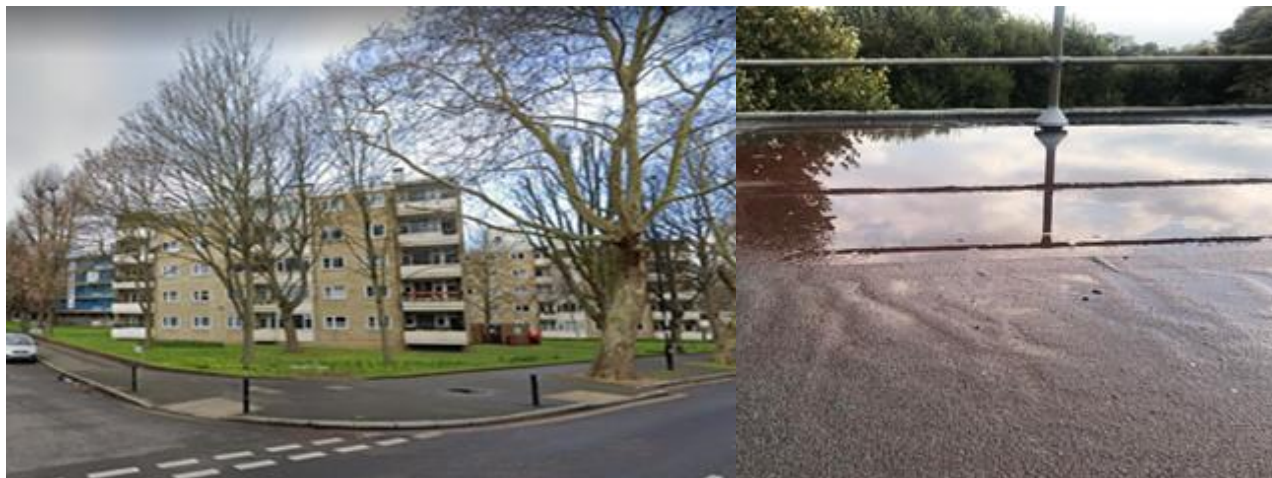
10. 1-37 and 39-77 Highbury Quadrant

Highbury Quadrant are five-storey T-blocks with cantilevered stairwells and balconies. The blocks have built in cavity walls and reinforced concrete construction with solid brick walls at the gable ends. The flat roof here are the last of two flat roofs of the five-storey style of blocks on the estate that have not yet had their roofs renewed. There have been many repairs carried out over the years, some sections have had patch repairs with granolithic felt and some outlets have been mended.

However, in both cases the original asphalt covering has deteriorated to the point where water is now getting into the insulated layer underneath and compromising the effectiveness of the roof. Options have been given to renew the roof with a new multi-layer elastomeric system in tapered falls to prevent ponding or a similar flat roof felt system to the one currently on the roof. Both systems will be an approved Langley specification which will provide improved insulation and energy performance for the block.

- Scaffolding of the whole block will be required
- Roof will be renewed. A decision on whether to go with a flat roof system (current roof covering) or tapered system (eliminates pooling of water by directing the rainwater to nearby outlets) is still to be decided
- Clearing and clean moss, clean outlets
- Render repairs to chimneys
- Replacement of tank room doors and painting
- Adjustment of thresholds to cater for new insulation
- Checking and testing of lightning conductor

- Easing and adjusting of UPVc windows including replacing missing/broken ironmongery including renewal of putty of communal Georgian wire glass and replacing any cracked glazing to these blocks.

- Tidy any cables to scaffolded areas
- Brickwork and masonry repairs including any concrete reinforcement repairs, render repairs and repointing where required – including brick tint and stain removal

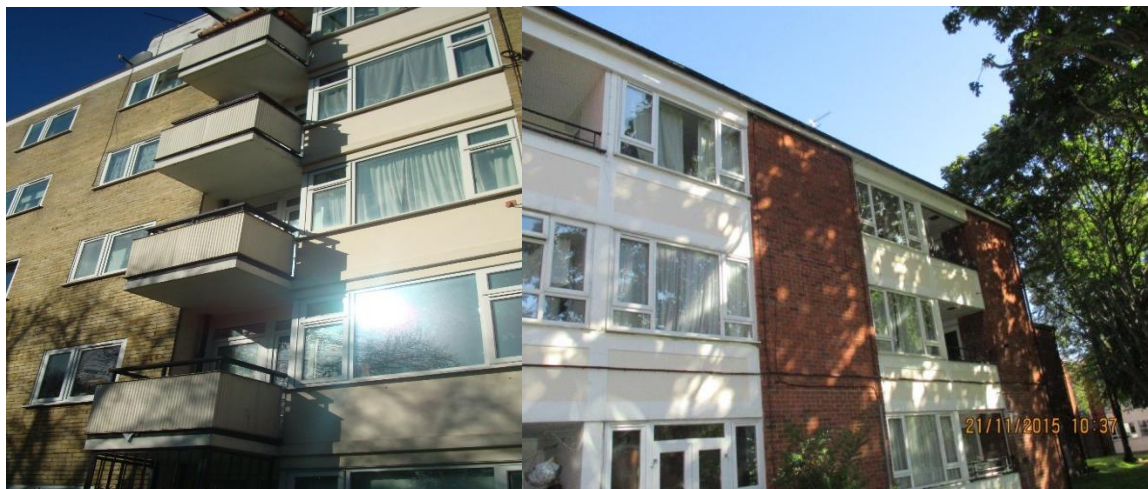
11.79-115 and 18-120 Highbury Quadrant

79-115 and 82-120 Highbury Quadrant is a five-storey T-blocks with cantilevered stairwells and balconies. The blocks have built in cavity walls and reinforced concrete construction with solid brick walls at the gable ends. The flat roof to this block has been renewed over the years and is still under warranty. The works that we have outlined for this block are as follows:

- Scaffolding to the whole block will be required.
- Repairs to flat roof.
- Core samples/moisture mapping will be undertaken to assess the condition and trace saturation levels.
- Clearing and clean moss, clean outlets

- Easing and adjusting of UPVc windows including replacing missing/broken ironmongery Including renewal of putty of communal Georgian wire glass and replacing any cracked glazing to these blocks.

- Tidy any cables to scaffolded areas
- Brickwork and masonry repairs including any concrete reinforcement repairs, render repairs and repointing where required – including brick tint and stain removal

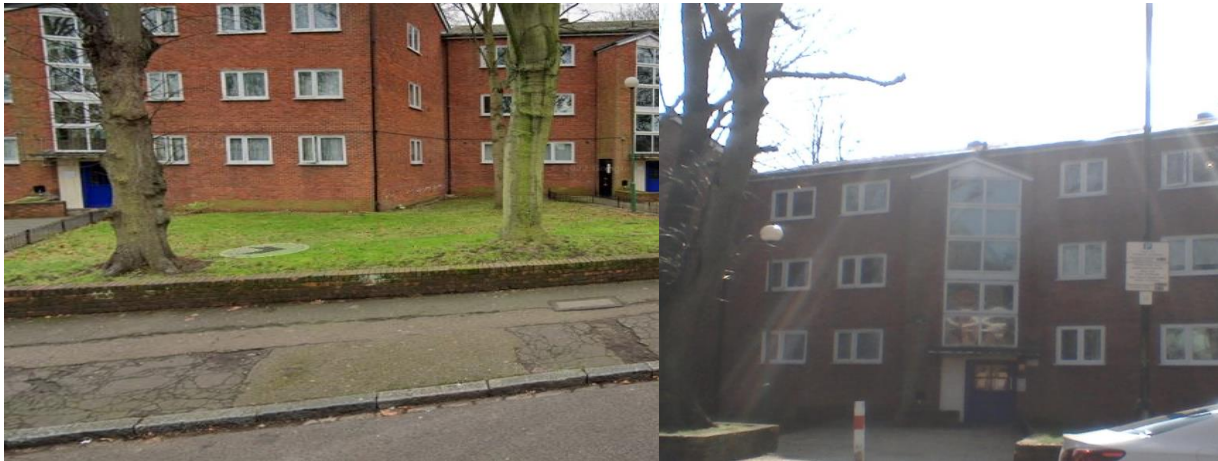
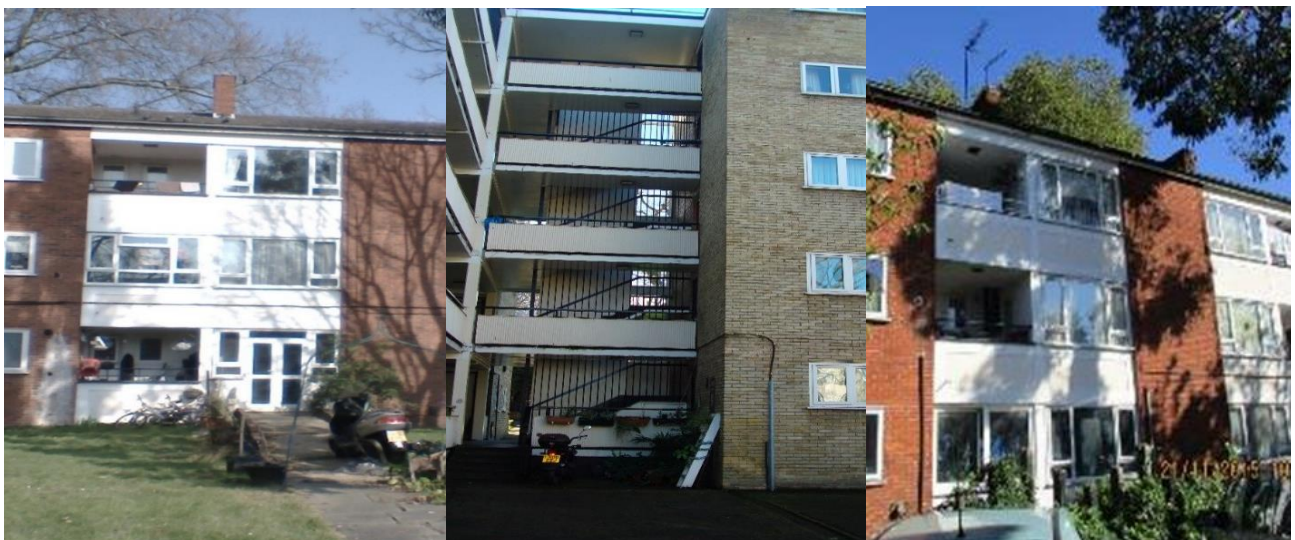
12. 117-127, 129 – 139, 141- 151, 153 – 163 and 145 – 167 Highbury Quadrant and 169 – 191 Highbury New Park

117-127, 129 – 139, 141 – 151, 153-163 and 145-167 Highbury Quadrant and 169 – 191 Highbury New Park are constructed of brick and reinforced concrete floor construction and solid brick wall at the gable ends. The low-pitched roofs are covered in slate tiles. The works to be undertaken to the block in question are as follows:

- Scaffolding to whole rear of block will be required
- Repairs to pitched tiled roof to including refixing loose tiles, replacing missing/broken tiles.
- Repairs to front entrance porch roof - felt

- Tidy cables where scaffold is erected only
- Masonry and brickwork repairs including any repointing and concrete repairs as well as brick tint and stain removal

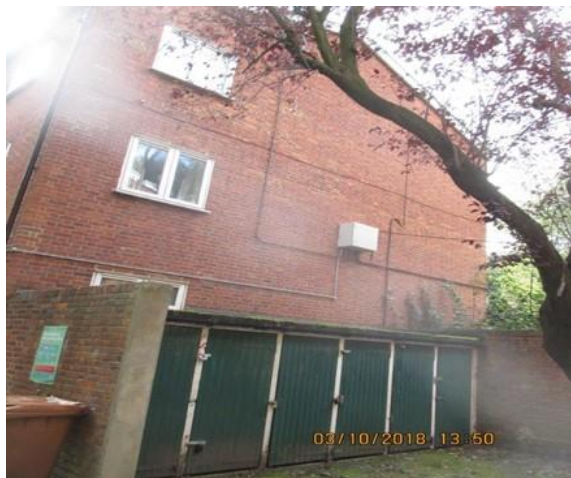
13. 152-190 Highbury New Park.

152-190 Highbury New Park is a five-storey T-blocks with cantilevered stairwells and balconies. The blocks have built in cavity walls and reinforced concrete construction with solid brick walls at the gable ends. The works that have been identified to be carried out are:

- Scaffolding the whole block.
- Repairs to flat roof.
- Core samples/moisture mapping will be undertaken to assess the condition.
- Clearing and clean moss, clean outlets and paint and repair tank room doors. balcony including replacing grills

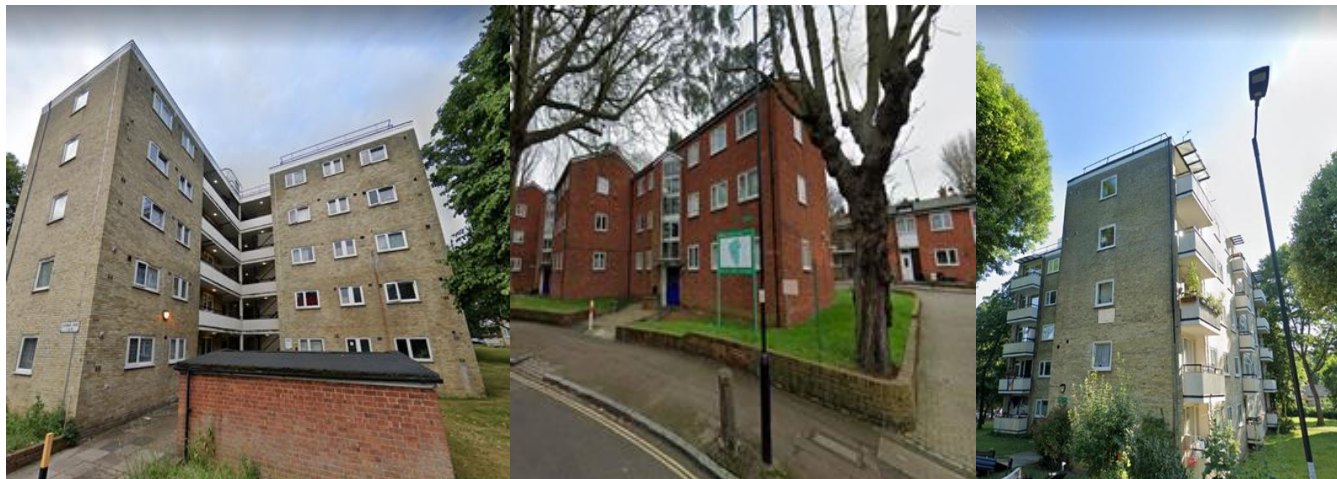
14. 192-230, 193-231 and 323-270 Highbury New Park and 1-39 Catherall Road

192 – 230, 193-231 and 232-270 Highbury New Park and 1-39 Catherall Road are five-storey T-blocks with cantilevered stairwells and balconies. The blocks have built in cavity walls and reinforced concrete construction with solid brick walls at the gable ends. Most of the flat roofs to these blocks have been renewed over the years and are still under warranty. The works to be programmed for this block will be the following:
