Cyclical Improvement Works

Resident consultation

EP04 - Highbury New Park

15 December 2022

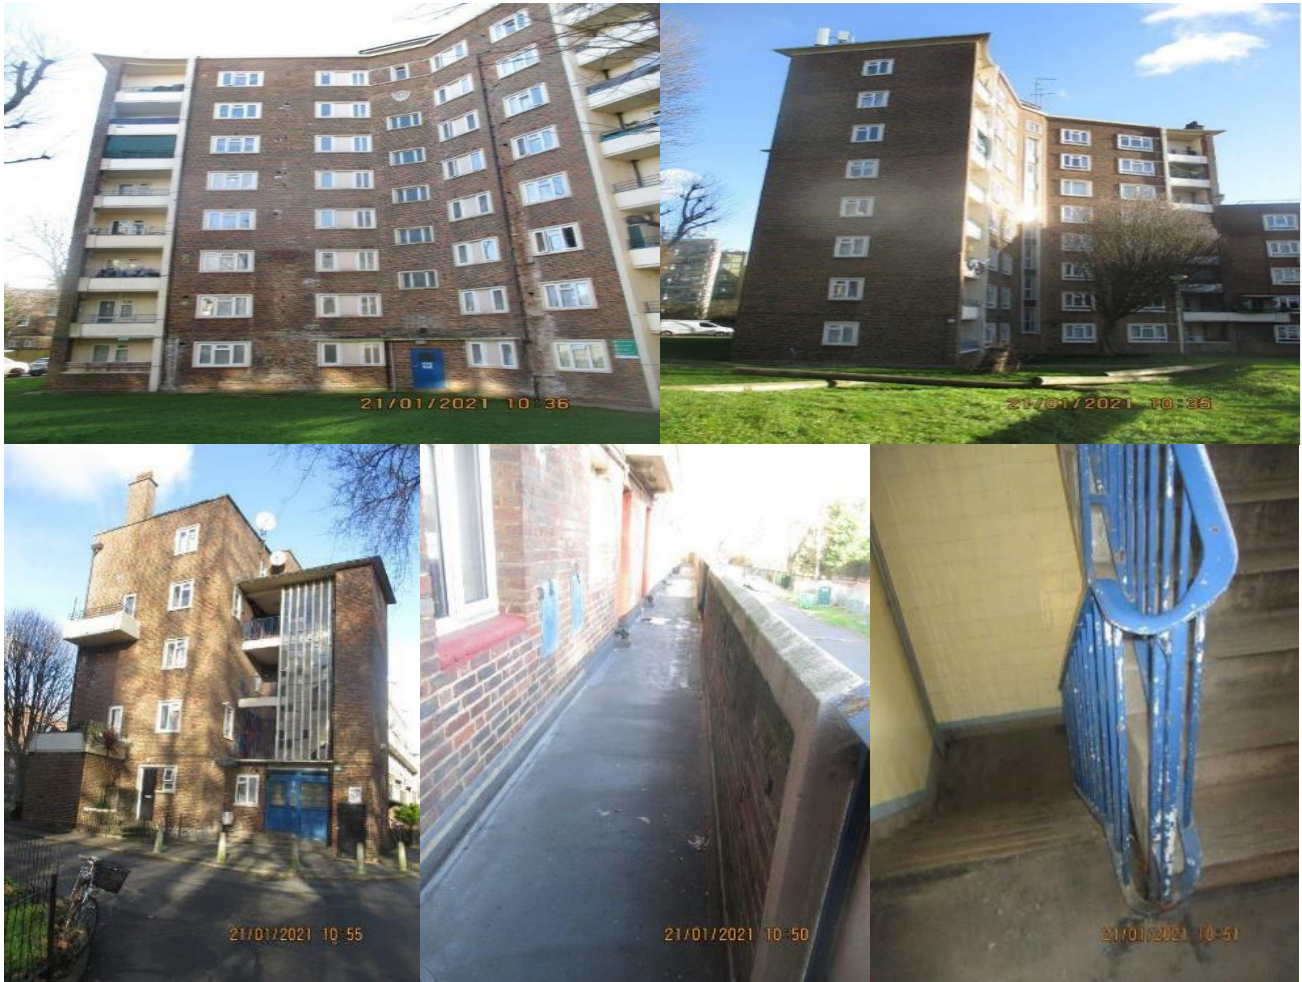
1. 1-52 Park View

1-52 Park View is a unique block on the estate, that was constructed in 1954. It is an 8-storey block constructed in reinforced concrete frame with brick infill and a connected adjoining 4-storey low-rise section in brick construction with cantilevered balconies. The low-rise section has a taller 5-storey section at the southwest facing gable end. The block also benefits from a controlled door entry system. The works to be undertaken at this block will require us to erect a scaffolding (Tube & Clip) to the entirety of the building. This will enable to gain access to difficult areas that are essential for the works we have specified to be carried out: The works will be carrying out at 1-52 Park View are as follows:

- The clearance of outlets, cleaning of moss
- Minor flat roof repairs to felt overlay, repointing of flashing around chimney stacks
- Checking and test of the lightning conductor.

- Ease and adjusting of all windows and renewal of missing ironmongery
- Renewal of putty and some Georgian wire glass to the communal areas.

- Brickwork, concrete and render repairs will be undertaken to large areas of 1-25 which will include brick tint and staining
- Repairs to tiled porch outside maisonettes front entrance doors
- Renewal of expansion joints
- Water resistant treatment to ground floor brickwork
- Jet washing of brickwork
- In block 1-25 clean out bin hoppers to each floor (including easing and adjusting), remove pigeon guano from secondary means of escape leading to the rear of the block.
- We plan on relocating the bin storage area to the grass area opposite 1-25 Park View due to the current location of the bins posing a possible fire risk.

The low-rise block where flats 25-52 are located, will undergo works aimed at strengthening the communal walkway balustrades. The initial plan was to demolish the wall and replace this with a powder coating railing that would match the design of the New Build homes. However, we would rather adapt the current design and overall look of the block.

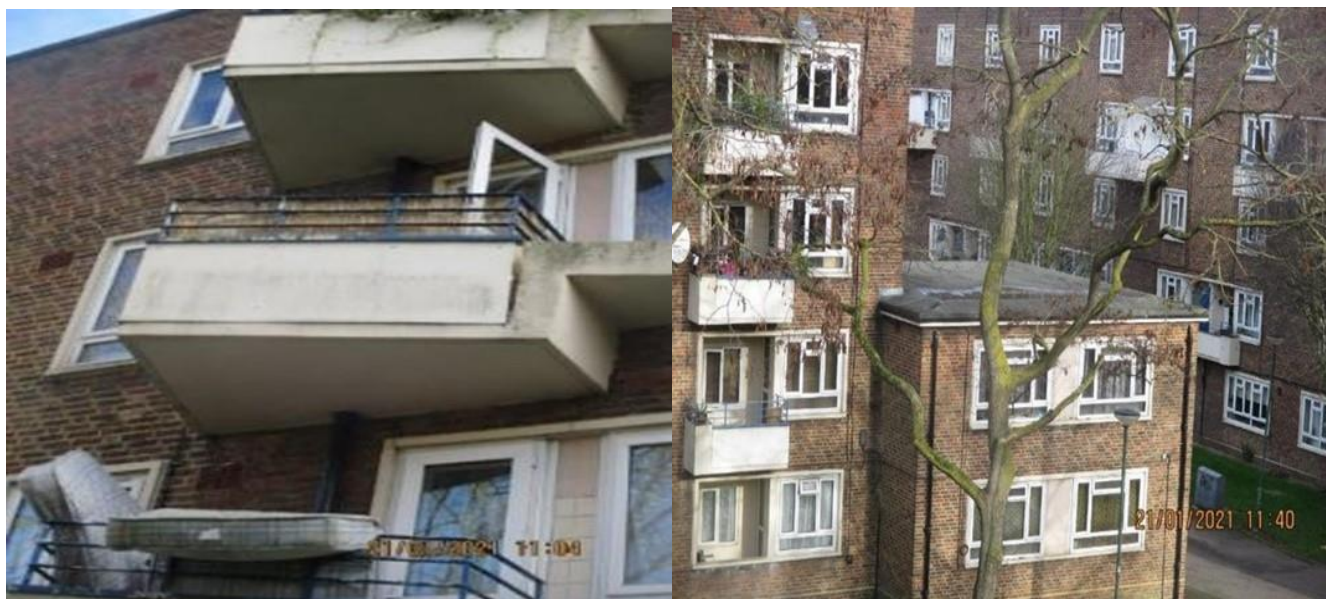
2. 53-68 Park View

Blocks 53-68 Park View are of a similar style to Block 1-52, built in brick and reinforced concrete frame construction with a cantilevered protruding stairwell and flat roofs. This block consists of four and two storey blocks. Due to the extensive works that will be undertaken at 53-68 Park View all elevations will need to have a (Tube and Clip) scaffolding erected. These works consist of the following:

- The clearance of outlets, cleaning of moss
- Minor flat roof repairs to felt overlay, repointing of flashing around chimney stacks
- Checking and test of the lightning conductor
- Testing such as moisture mapping and core samples maybe taken to determine
- Repointing flashing around chimney stacks

- Ease and adjusting of all windows and renewal of missing ironmongery
- Renewal of putty and some Georgian wire glass to the communal areas.

- Brickwork, concrete and render repairs, to include brick tint and staining
- Renewal expansion joints.

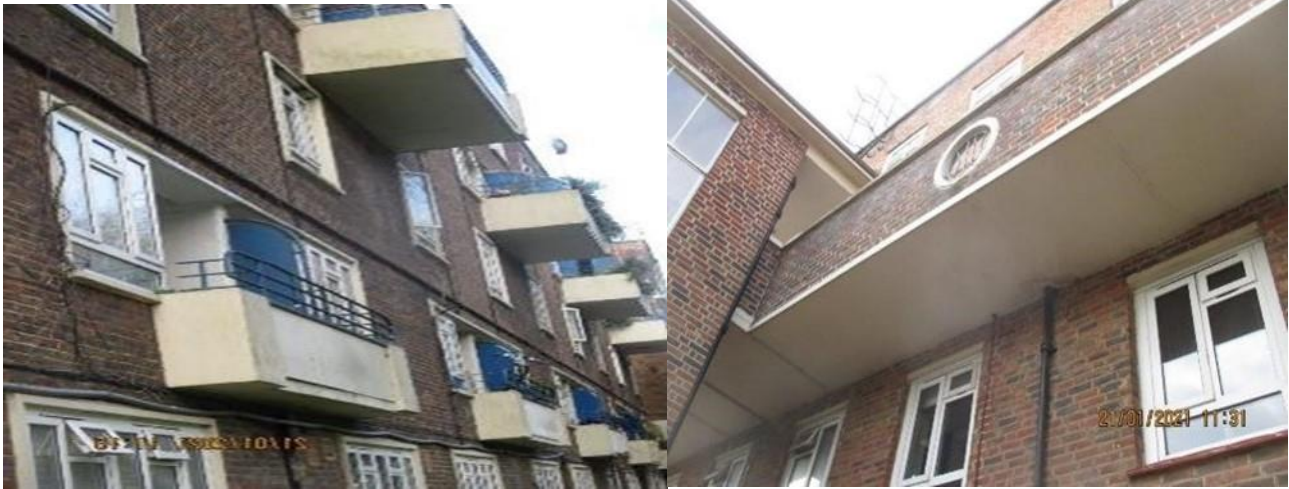
3. 69-96 Park View

Blocks 69-96 Park View is of the same style as the low-rise section of block 1-52. Built in brick construction and reinforced concrete frame with cantilevered communal balcony walkway to the front elevation and individual balconies to the rear elevation and a flat roof system. The works required for this block will require a Tube and Clip scaffolding that will be erected to both two and four storey blocks in order for the following works to be undertaken:

- The clearance of outlets, cleaning of moss.
- Minor flat roof repairs to felt overlay.
- Repointing of flashing around chimney stacks.
- Clear and wash down rainwater goods.
- Checking and test of the lightning conductor.
- Testing such as moisture mapping and core samples may be taken to determine. We will repoint flashing around chimney stacks.
- One layer felt overlay to pram sheds.

- Repairs to tiled porch outside maisonettes front entrance doors.
- Renewal of expansion joints.

Low-rise blocks containing walkways will undergo works aimed at strengthening the balustrades to the communal walkways. The initial plan was to demolish the wall and replace this with a powder coating railing that would match the design of the New Build. However, we would rather adapt the current design and overall look of the block.

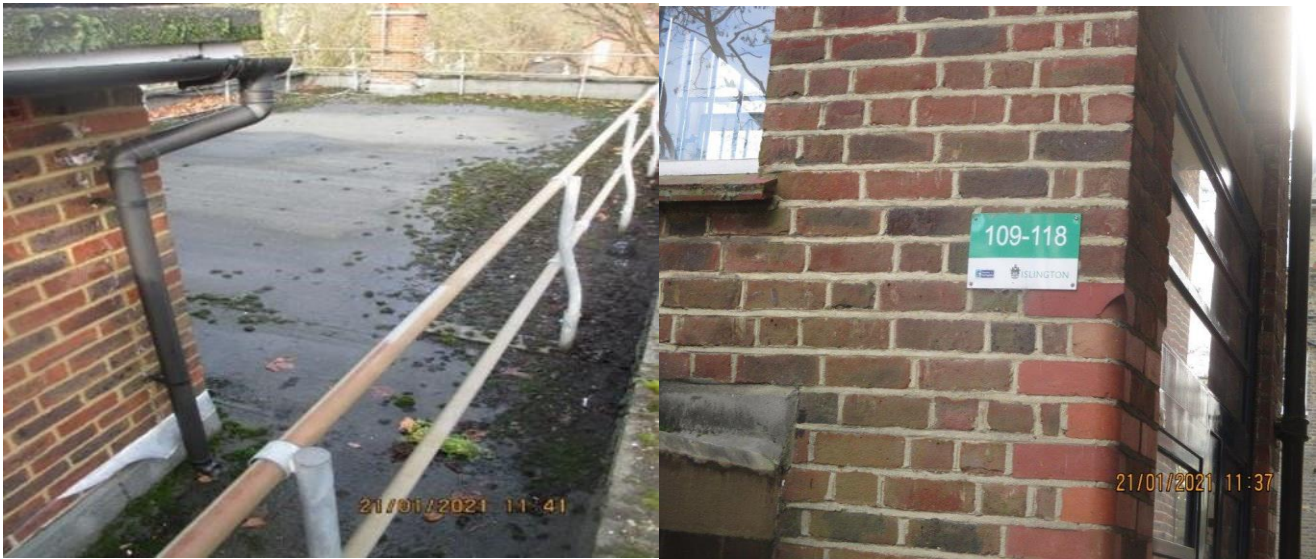
4. 109-118 Park View

Blocks 109-118 Park View are of a similar style to Block 1-52, built in brick and reinforced concrete frame construction with a cantilevered protruding stairwell and flat roofs. This block consists of four and two storey blocks. Due to the extensive works that will be undertaken at 109-118 Park View all elevations will need to have a (Tube and Clip) scaffolding erected. These works consist of the following:

- The clearance of outlets, cleaning of moss.
- Minor flat roof repairs to felt overlay, repointing of flashing around chimney stacks.
- Checking and test of the lightning conductor.
- Testing such as moisture mapping and core samples maybe taken to determine. We will repoint flashing around chimney stacks.
- One layer felt overlay to pram sheds.

- Brickwork, concrete and render repairs, to include brick tint and staining.
- Renewal expansion joints.

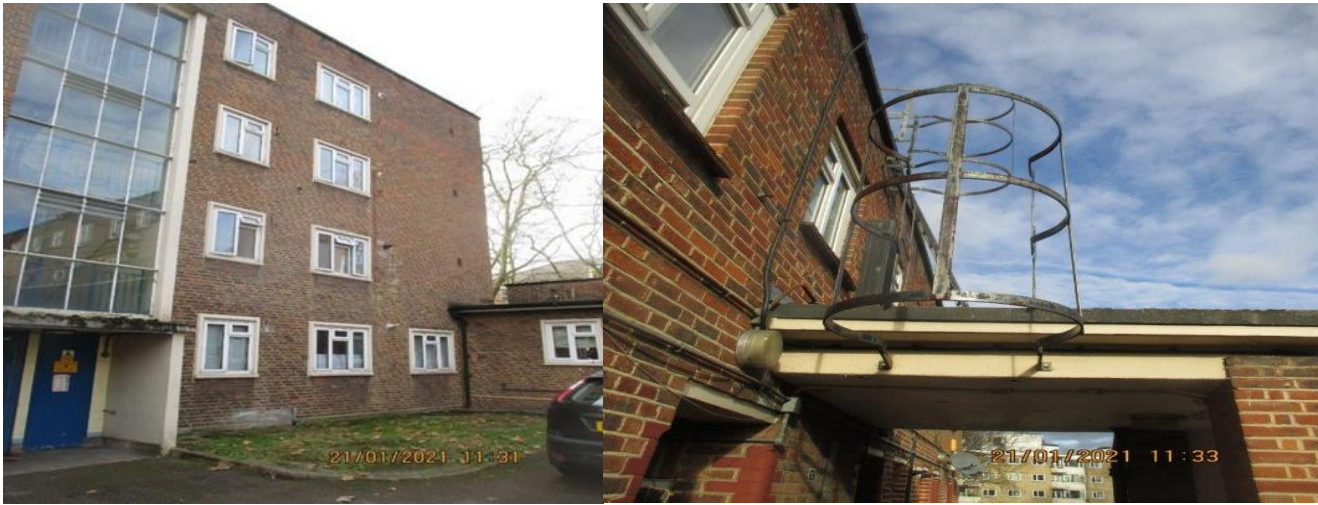
5. 119-142 Park View

119-142 Park View Estate are of the same style as the low-rise section of block 1-52. Built in brick construction and reinforced concrete frame with cantilevered communal balcony walkway to the front elevation and individual balconies to the rear elevation and a flat roof system. This block consists of four and two storey blocks. Due to the extensive works that will be undertaken at 109-118 Park View all elevations will need to have (Tube and Clip) scaffolding to be erected. These works consist of the following:

- The clearance of outlets, cleaning of moss.
- Minor flat roof repairs to felt overlay, repointing of flashing around chimney stacks.
- Checking and test of the lightning conductor.
- Testing such as moisture mapping and core samples may be taken to determine.
- Repointing flashing around chimney stacks.
- One layer felt overlay to pram sheds

Low-rise blocks containing walkways will undergo works aimed at strengthening the balustrades to the communal walkways. The initial plan was to demolish the wall and replace this with a powder coating railing that would match the design of the New Build. However, we would rather adapt the current design and overall look of the block:

- Rebar works to be undertaken within walkway balustrades to provide required reinforcement.
- Complete resurfacing of the communal balcony walkway surfaces using a product that incorporates a new insulation layer. Creating channels in the existing water gullies to ensure rain falls into the gullies and is drained away.
- Replacement of gully grids to walkways and connected down pipes – cast iron – repair sections and seal around entrances into flats where and when necessary.

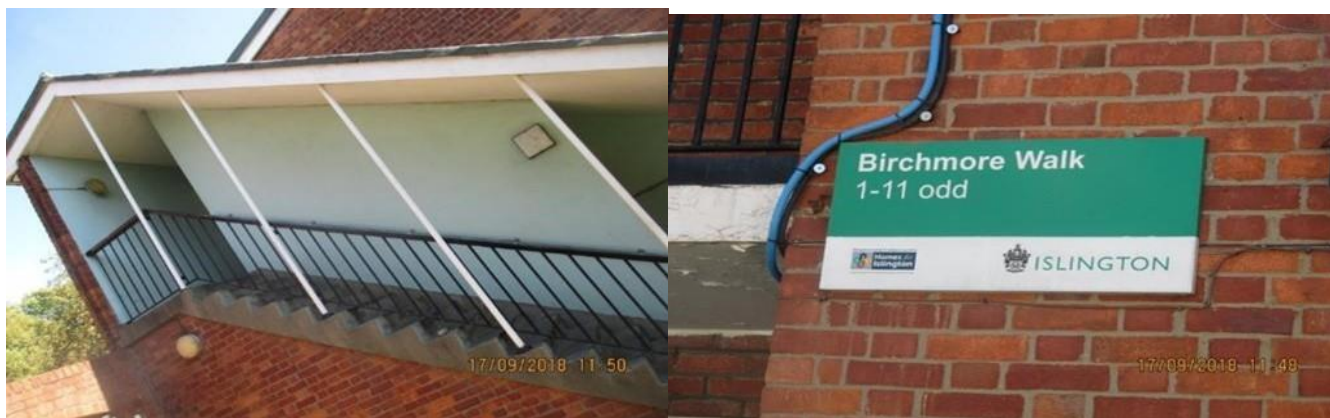
6. 1-11 Birchmore Walk

1 to 11 Birchmore Walk is part of an open aspect 2-storey block of a similar style, both are cavity wall brick construction with reinforced concrete deck and frame with low-level pitched roofs. The main differences are the yellow brick façade construction. These works consist of the following:

- Scaffolding of the whole block will be essential to gain access to areas where works are required to be undertaken at the blocks for Birchmore Walk.
- Minor roof repairs to main pitched roof including replacement of broken tiles, damaged battens and isolation to be checked and replaced if required.

- Brickwork and concrete repairs including brick tint and stain removal.

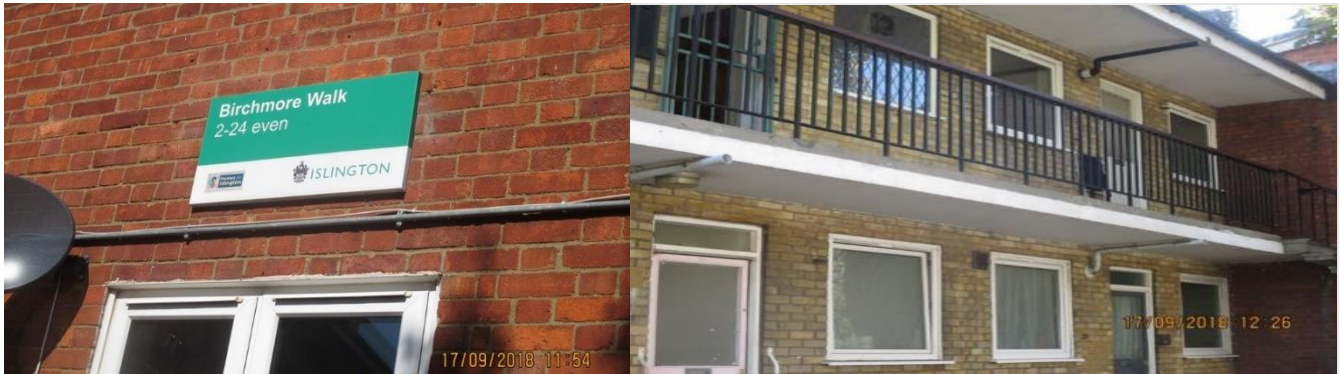
7. 2-24, 26 - 48 and 50 – 72 Birchmore Walk

2-24, 26 – 38 and 50-72 Birchmore Walk are three-storey style blocks that have built in cavity wall construction, solid walls at the gable ends with pitched roofs covered in artificial slate. These blocks also benefit from a controlled door entry system at the entrance to each protruding stairwell section. These works consist of the following:

- Scaffolding to whole rear of block (double check flank ends) and to stairwell entrances at the front of the blocks.
- Repairs to pitched tiled roof to including refixing loose tiles, replace missing/broken tiles, clearing and realigning guttering and downpipes where required.
- Repairs to timber fascias and soffits. Application of weatherproof solutions.
- Checks to loft areas – replace insulation where required.
- Renewal of roof hatches top of landings.

- Tower (three-storey) for downpipe repairs etc to front elevation
- Repairs to front entrance porch roof – felt.
- Tidy cables where scaffold is erected only.
- Some masonry and brickwork repairs including any repointing and concrete repairs as well as brick tint and cleaning off stains.

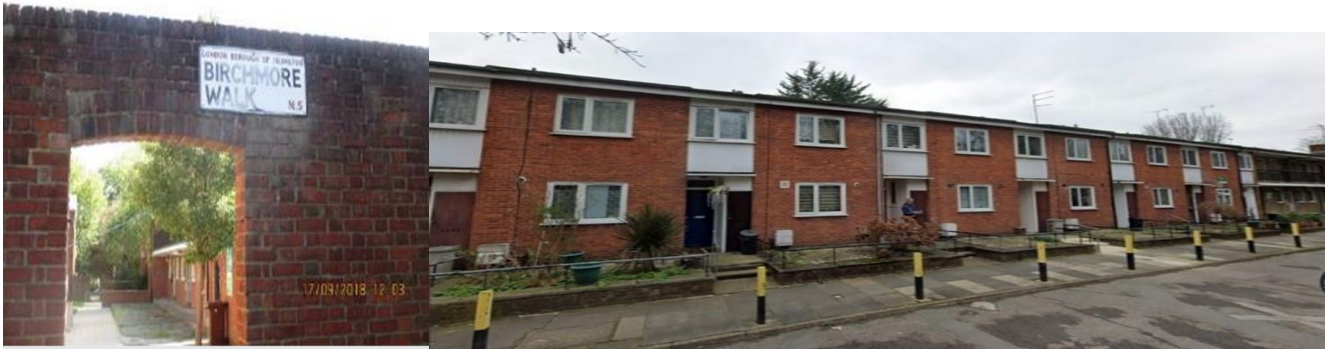
8. 13 – 25, 27 – 39, 41-61 and 73-85 Birchmore Walk

Blocks 13-25, 27-39, 41-61 and 73 - 85 Birchmore Walk are mainly two-storey terraced houses and individual homes. These have built in cavity wall construction with low-level felt covered pitched roofs with a recessed louvre window detail at regular intervals. The works required are as follows:

- Repairs to pitched tiled roof including refixing loose tiles, replace missing/broken tiles.
- Renewal of battens where required.
- Loft insulation to tenanted properties.
- Clearing of rainwater goods including renewal of joints/brackets and small sections.
- Repairs to fascia/soffits and weatherproof solution applied.

- Brickwork repointing - including brick tint and stain removal.

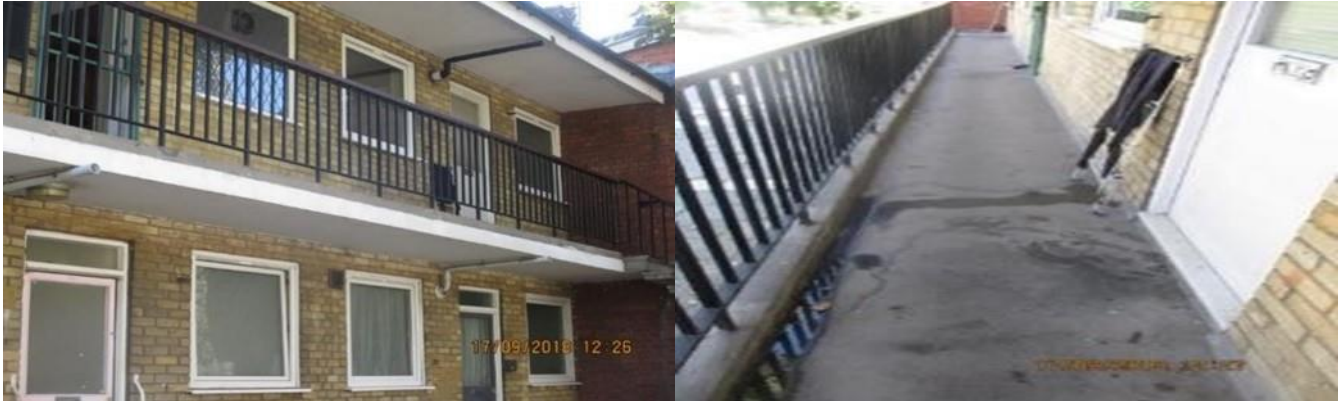
9. 63-71 Birchmore Walk

Block 63 -71 Birchmore Walk are open aspect two-storey blocks of a similar style, both are cavity wall brick construction with reinforced concrete deck and frame and low-level pitched roofs. The main differences are the yellow brick façade construction and rear elevation cladding detail on block 63-71. The works we have identified as being required at 63-71 Birchmore Walk are:

Minor roof repairs to main pitched roof including replacement of broken tiles, damaged battens and insulation to be checked and replaced if required including any flashings.

- Fire compliancy works to cladding detail at rear elevation block 63-71 only. (To be confirmed after FRA survey recommendations for works to be undertaken after we start work).

- Recoating of the asphalt walkway to block which has deteriorated in new PMMA water resistant cold applied coating.

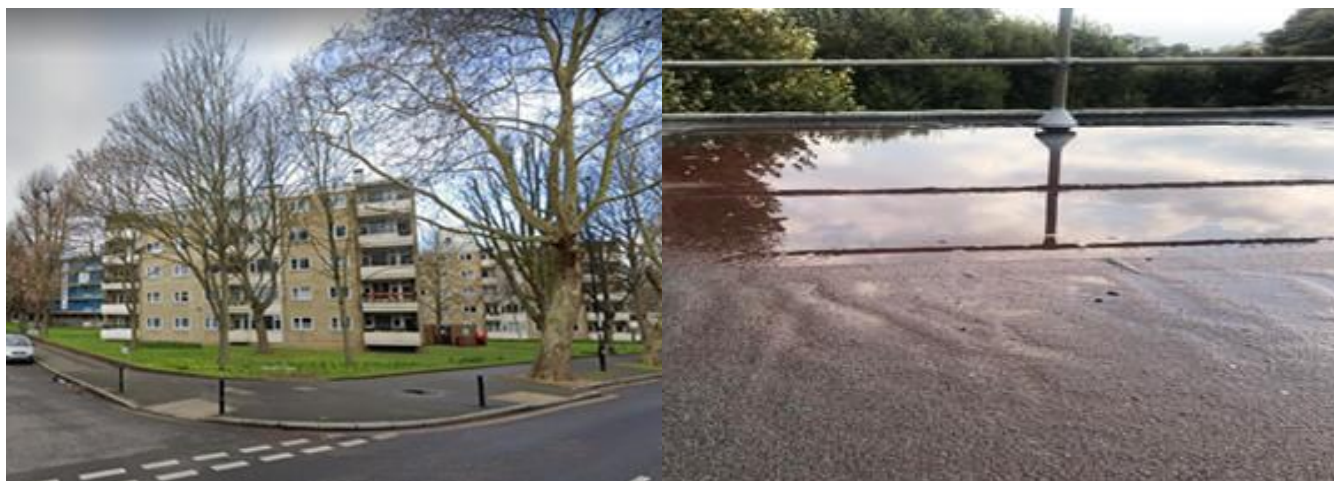
10. 1-37 and 39-77 Highbury Quadrant

Highbury Quadrant are five-storey T-blocks with cantilevered stairwells and balconies. The blocks have built in cavity walls and reinforced concrete construction with solid brick walls at the gable ends. The flat roof here are the last of two flat roofs of the five-storey style of blocks on the estate that have not yet had their roofs renewed. There have been many repairs carried out over the years, some sections have had patch repairs with granolithic felt and some outlets have been mended.

However, in both cases the original asphalt covering has deteriorated to the point where water is now getting into the insulated layer underneath and compromising the effectiveness of the roof. Options have been given to renew the roof with a new multi-layer elastomeric system in tapered falls to prevent ponding or a similar flat roof felt system to the one currently on the roof. Both systems will be an approved Langley specification which will provide improved insulation and energy performance for the block.

- Scaffolding of the whole block will be required.
- Roof will be renewed. A decision on whether to go with a flat roof system (current roof covering) or tapered system (eliminates pooling of water by directing the rainwater to nearby outlets) is still to be decided.
- Clearing and clean moss, clean outlets.
- Render repairs to chimneys.
- Replacement of tank room doors and painting.
- Adjustment of thresholds to cater for new insulation.
- Checking and testing of lightning conductor.

- Tidy any cables to scaffolded areas.
- Brickwork and masonry repairs including any concrete reinforcement repairs, render repairs and repointing where required – including brick tint and stain removal.

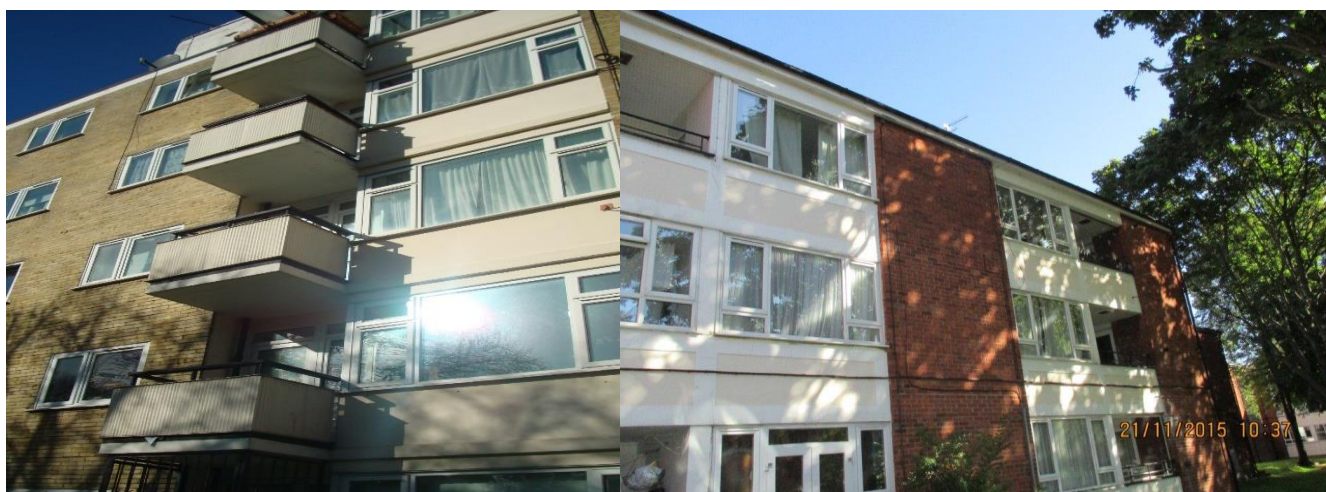
11.79-115 and 82-120 Highbury Quadrant

79-115 and 82-120 Highbury Quadrant is a five-storey T-blocks with cantilevered stairwells and balconies. The blocks have built in cavity walls and reinforced concrete construction with solid brick walls at the gable ends. The flat roof to this block has been renewed over the years and is still under warranty. The works that we have outlined for this block are as follows:

- Scaffolding to the whole block will be required.
- Repairs to flat roof.
- Core samples/moisture mapping will be undertaken to assess the condition and trace saturation levels.
- Clearing and clean moss, clean outlets

- Tidy any cables to scaffolded areas.
- Brickwork and masonry repairs including any concrete reinforcement repairs, render repairs and repointing where required – including brick tint and stain removal.

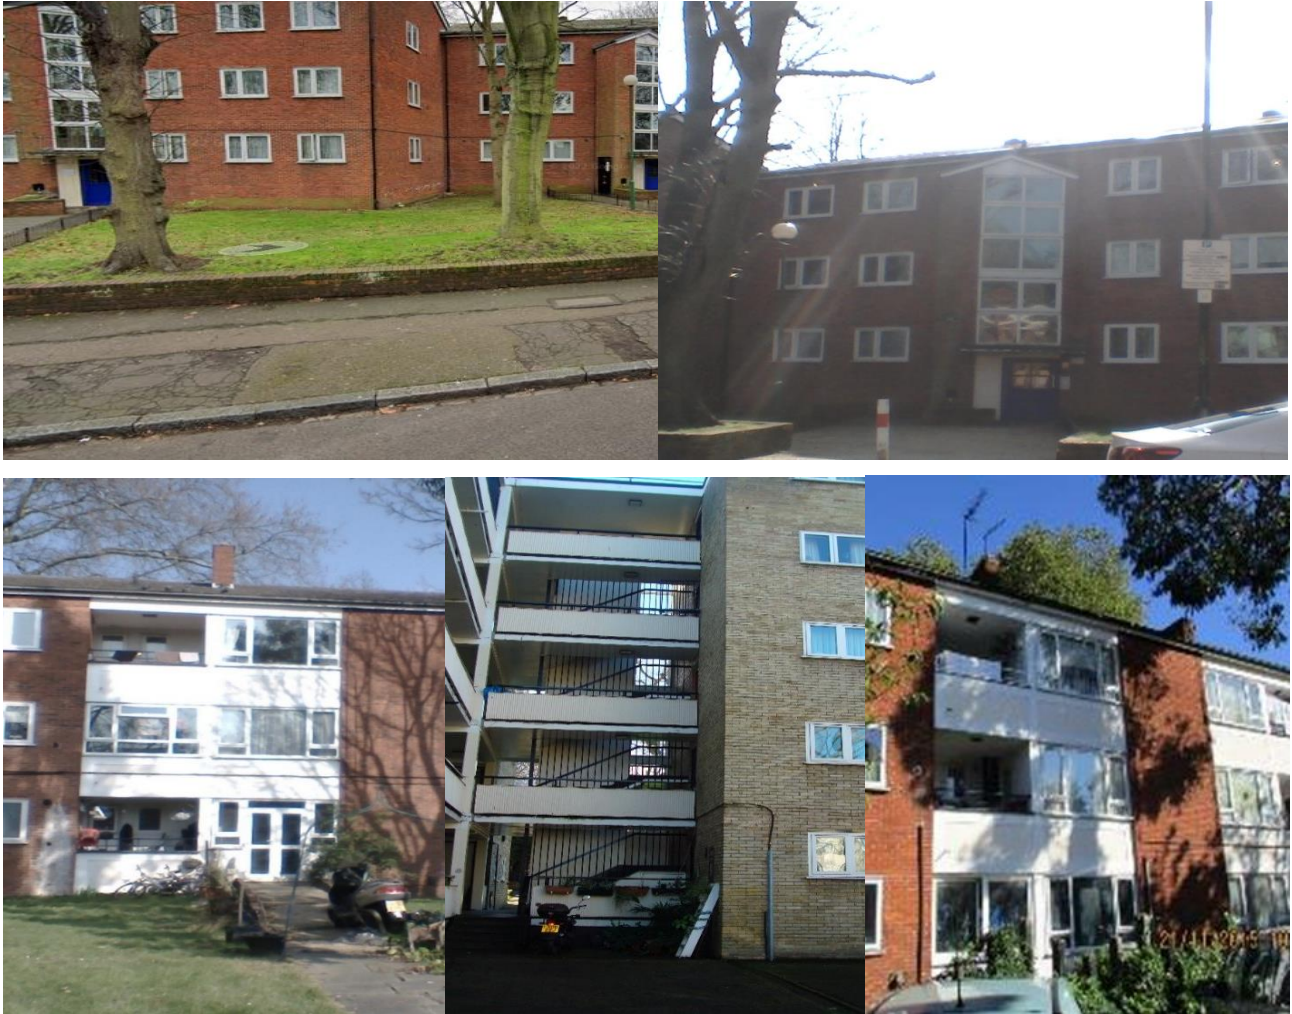
12. 117-127, 129 – 139, 141- 151, 153 – 163 and 145 – 167 Highbury Quadrant and 169 – 191 Highbury New Park

117-127, 129 – 139, 141 – 151, 153-163 and 145-167 Highbury Quadrant and 169 – 191 Highbury New Park are constructed of brick and reinforced concrete floor construction and solid brick wall at the gable ends. The low-pitched roofs are covered in slate tiles. The works to be undertaken to the block in question are as follows:

- Scaffolding to whole rear of block will be required.
- Repairs to pitched tiled roof to including refixing loose tiles, replacing missing/broken tiles.
- Repairs to front entrance porch roof – felt.

- Tidy cables where scaffold is erected only
- Masonry and brickwork repairs including any repointing and concrete repairs as well as brick tint and stain removal.

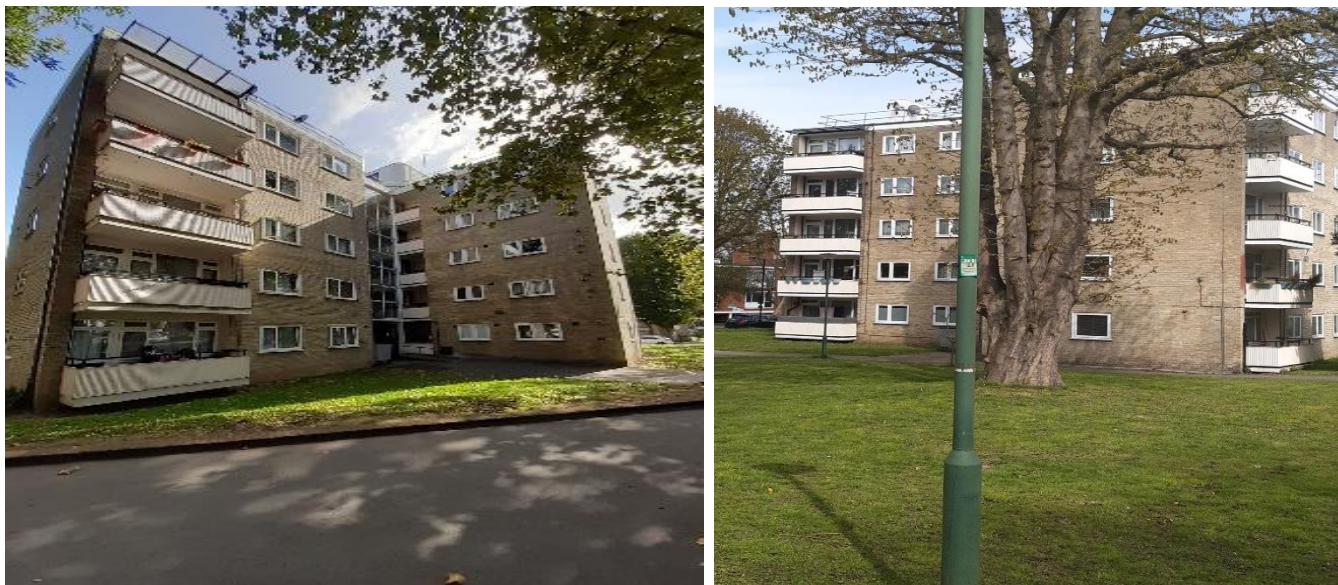
13. 152-190 Highbury New Park.

152-190 Highbury New Park is a five-storey T-blocks with cantilevered stairwells and balconies. The blocks have built in cavity walls and reinforced concrete construction with solid brick walls at the gable ends. The works that have been identified to be carried out are:

- Scaffolding the whole block.
- Repairs to flat roof.
- Core samples/moisture mapping will be undertaken to assess the condition.
- Clearing and clean moss, clean outlets and paint and repair tank room doors. balcony including replacing grills.

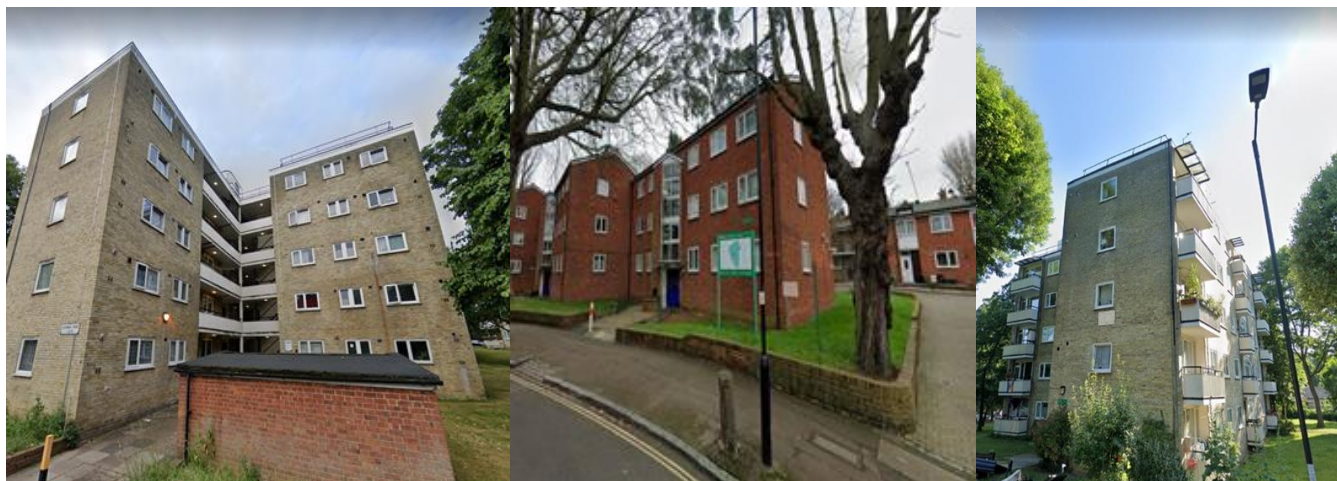
14. 192-230, 193-231 and 323-270 Highbury New Park and 1-39 Catherall Road

192 – 230, 193-231 and 232-270 Highbury New Park and 1-39 Catherall Road are five-storey T-blocks with cantilevered stairwells and balconies. The blocks have built in cavity walls and reinforced concrete construction with solid brick walls at the gable ends. Most of the flat roofs to these blocks have been renewed over the years and are still under warranty. The works to be programmed for this block will be the following:
